Motorcycle safety barrier trials in South Australia: Case study – Adelaide Hills

Department of Planning, Transport & Infrastructure, South Australia

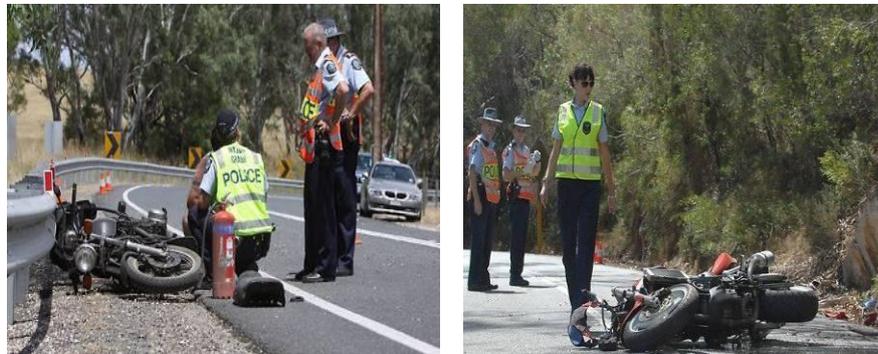
Figure 3: Examples of motorcycle crashes involving guard fence in the absence of a motorcycle protection system

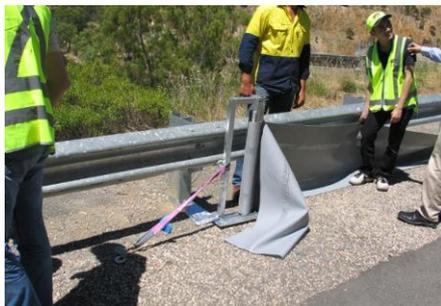
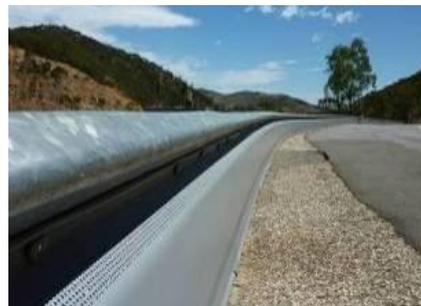
The flexible fabric barrier (as shown in Figure 4) providing a continuous protection system below the guard rail and in front of the posts, has met European impact safety tests to UNE 135900 for motorcycle riders (86.5 kg dummy, 60 km/h, 30 deg.) and EN 1317 for passenger cars (1.5t, 110 km/h, 20 deg.). The HIC index (Head Injury Criterion) that gauges the risk of head injuries ranged from around 60 at mid span to 470 at the post. The maximum HIC test value is set at 650 for Level-1 (1000 for Level-2). The fabric consists of a fireproof recyclable material with UV protection and performs at ambient temperatures of -20°C to +80°C according to product literature.

Figure 4: Motorcycle Protection Barrier - BASYC during and after installation

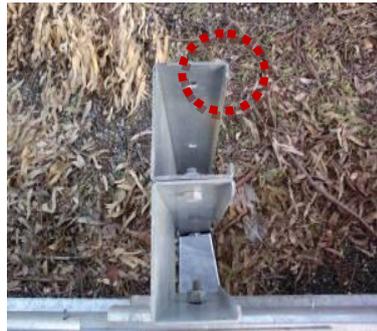
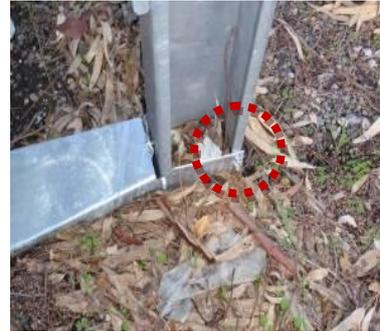
- Guard fence has been installed on three different types of steel posts (between terminals): ‘C’ posts, ‘Charlie’ posts and ‘cranked’ posts. The latest standard posts, ‘Charlie’ posts as shown in Figure 5, have a different shape to the ‘C’ post and require a different foot design – the ‘Victorian foot’ as shown in Figure 6.

Figure 5: Motorcycle Protection Barrier – BASYC on ‘Charlie Posts’

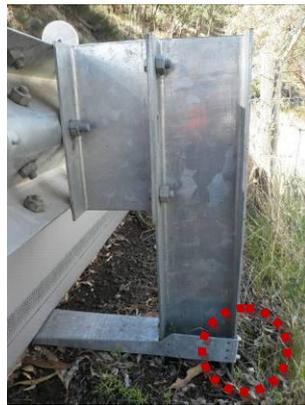
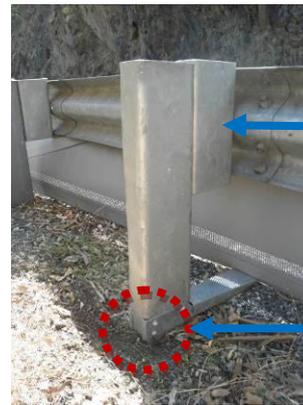
Figure 6: Motorcycle Protection Barrier – BASYC on C-Posts with Victorian foot

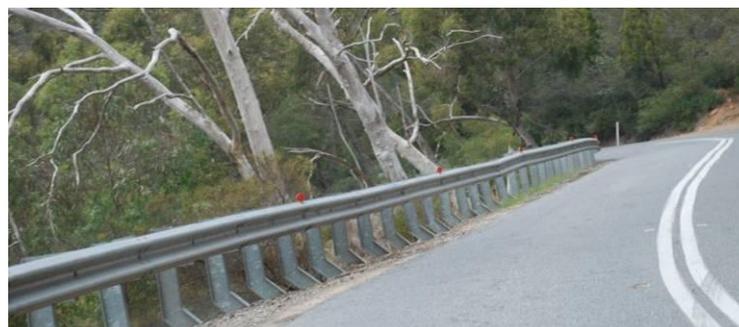
- A significant amount of the guard fence on Gorge Road is on cranked posts, which are not conducive to the installation of BASYC as there is nowhere to attach the foot. The profile of the cranked I-section post (as seen in Figure 7) leaves nowhere for the bracket of the foot to connect to at the required distance away from the mesh to allow the necessary deflection at ground level when impacted. This would be a major modification of the tested article and would require full scale testing. Each foot requires at least 8 screws or nails to hold it in place. Drilling the post flange at the base, i.e. where there is stress concentration, would affect the cranked post strength. Hence the lower foot for the BASYC fitted the ‘Charlie’ post and the ‘C’ post but not the cranked post. A different solution was preferred for the cranked posts to dissipate impact forces better around the posts and not require a lower foot.

Figure 7: Cranked Posts on a curve on Gorge Road

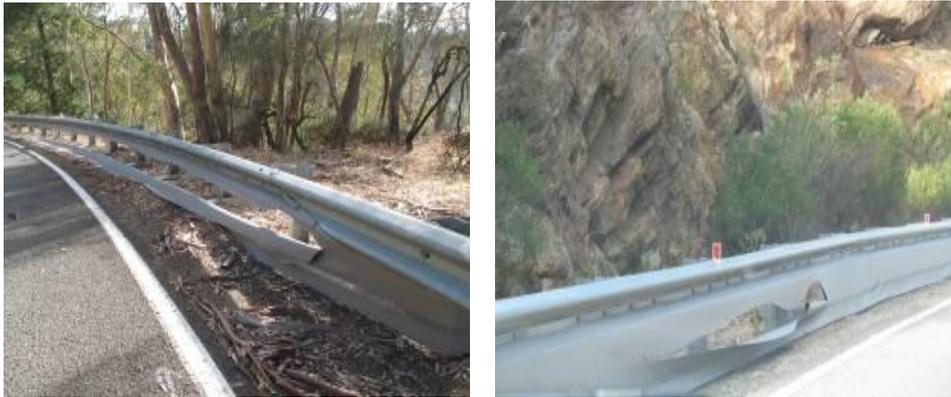
Vandalism has been a significant issue. The barrier was slashed at a number of locations within a year of installation as shown in Figure 8 and has been the biggest issue for maintenance crews to deal with.

Figure 8: Vandalised motorcycle protection system (BASYS) on Gorge Road

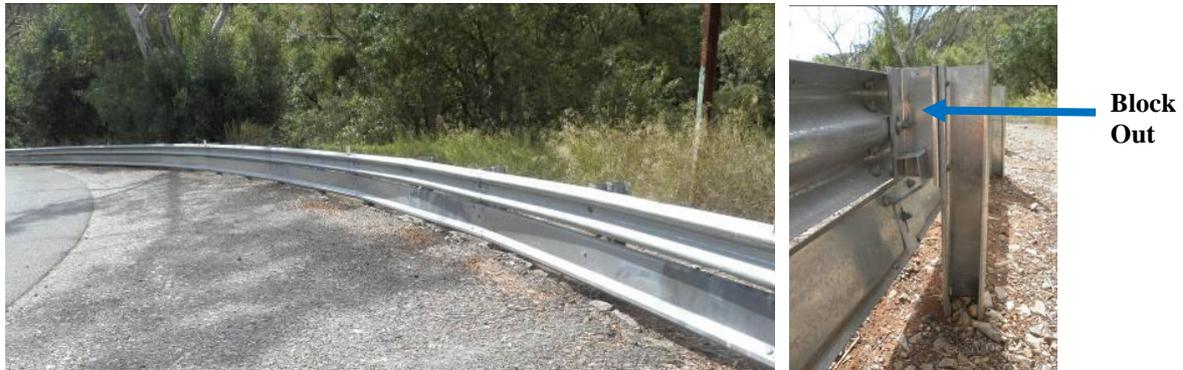
Figure 9: Steel Rail MPS on Gorge Road and Cudlee Creek Road

- Upon installation of the steel rail on the older style W-beam (C-posts) the block out was found to be slightly narrower than the Charlie posts and the steel rail bracket holes didn't match the holes on the block out (as shown in Figure 9). Wider holes were made in the supplied brackets to fit the older style W Beam, after being accepted by structural engineers for trial purposes.

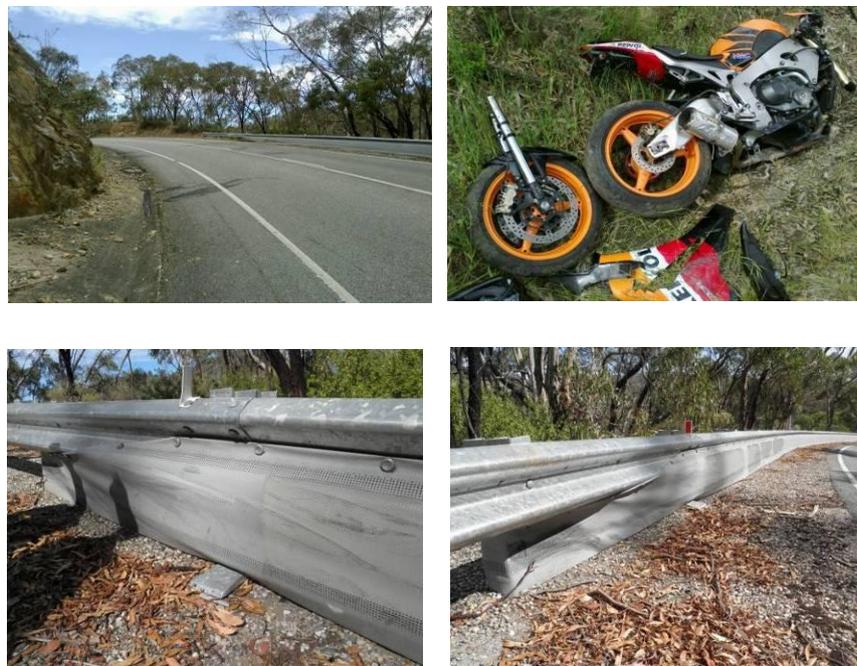
In one of the PDO crashes reported on Gorge Road in November 2011, a mature age rider on a Honda Fireblade motorcycle hit the flexible barrier on a tight corner on Gorge Road as identified in Figure 10.

Figure 10: Damaged motorcycle & BASYC barrier after crash on Gorge Road

The rider claimed that an opposing vehicle had been well over the centreline causing him to suddenly change his riding line and lose control. Evidence indicates the rider low-sided into the barrier and the bike’s forks were ripped out on the leading barrier post yet the rider walked away with only a reported cut to his right knee. According to reports, the helmet had the graphics worn away by the action of rubbing along the motorcycle barrier.

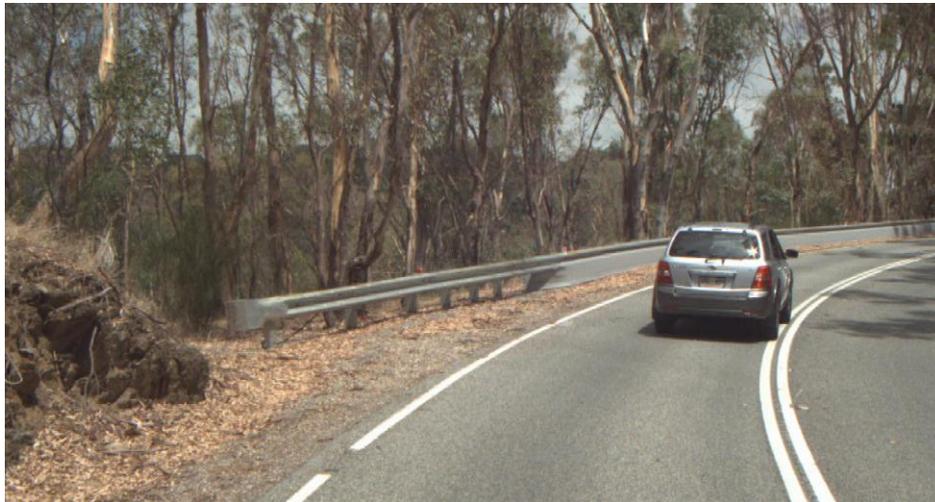
- The W-beam terminals were deliberately left untreated with MPS in both cases so as not to interfere with the operation of the terminal in the event of a car crash, as shown in Figure 11. However, it was noted in one case where the terminal is located on a curve due to a road cutting, a motorcycle had struck the post that the flexible mesh is terminated at (refer Figure 10).

Figure 11: End treatment of flexible mesh on Gorge Road
