Road Safety Study – Candia Road – ‘Before’ and ‘After’ Crash Monitoring

Bruno Royce

Traffic Engineering Solutions Ltd

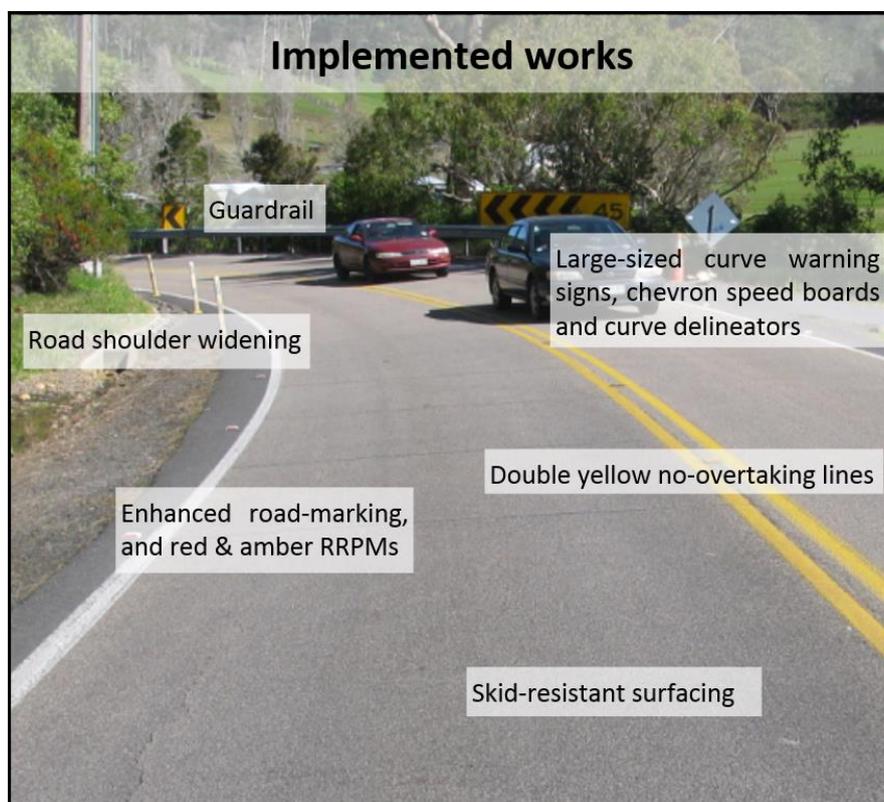
Figure 2: *Constructed works on the northern approach to the bend north of Vineyard Road. Similar works were implemented on the southern approach to this bend*

- **Curve warning signage and chevrons:** Upgrade quantity, size, visibility and double-gate;
- **Embankment:** Cut-back embankment to improve forward visibility on the inside of one bend;

- **Road shoulders:** Widen and seal road shoulders, to provide a more forgiving roadside and more opportunities for errant motorists to correct their vehicle if starting to lose control;

- **Shape correction:** To provide a smooth road surface and consistent super-elevation around the bends;
- **Skid resistant surface:** A highly skid-resistant road surface (Polished Stone Value > 70) at two bends, reducing likelihood of loss-of-control at the bends;

- **Water-cutting:** Water-cut the road surface on the approaches to the bends, to reduce the likelihood of loss-of-control crashes on the approaches to the bends, but with reduced expenditure (as opposed to skid resistant surfacing);

- **Guardrail:** Install guardrail, to prevent errant vehicles from R&R down an embankment on the outside of two bends;
- **No Overtaking:** Install thermoplastic double yellow 'No-Overtaking' lines, to discourage

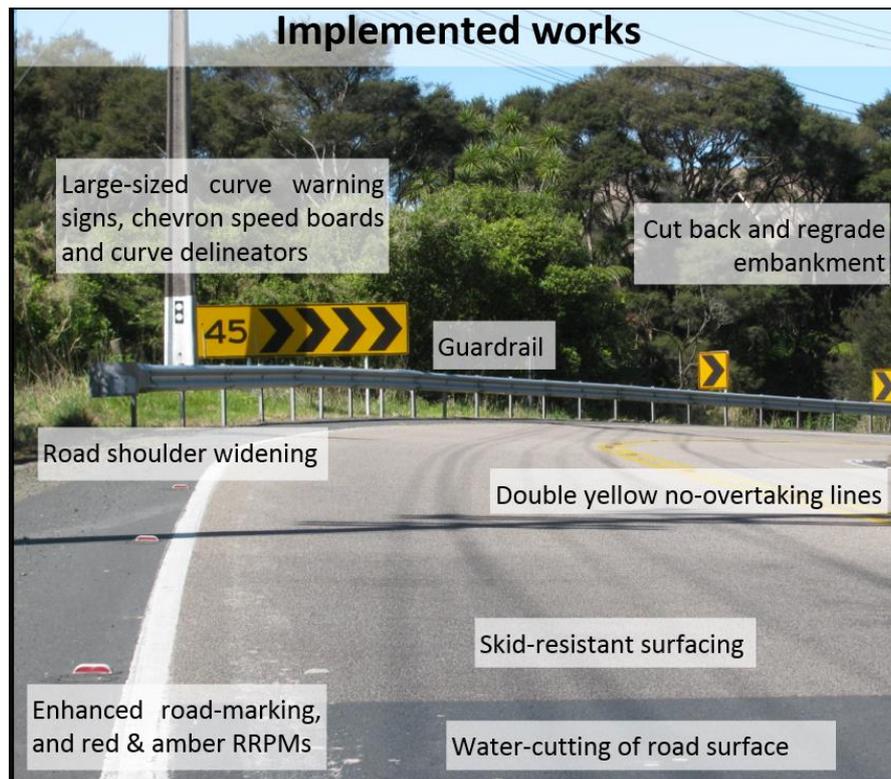
Figure 3: *Constructed works on the northern approach to the bend south of Vineyard Road. Similar works were implemented on the southern approach to this bend*

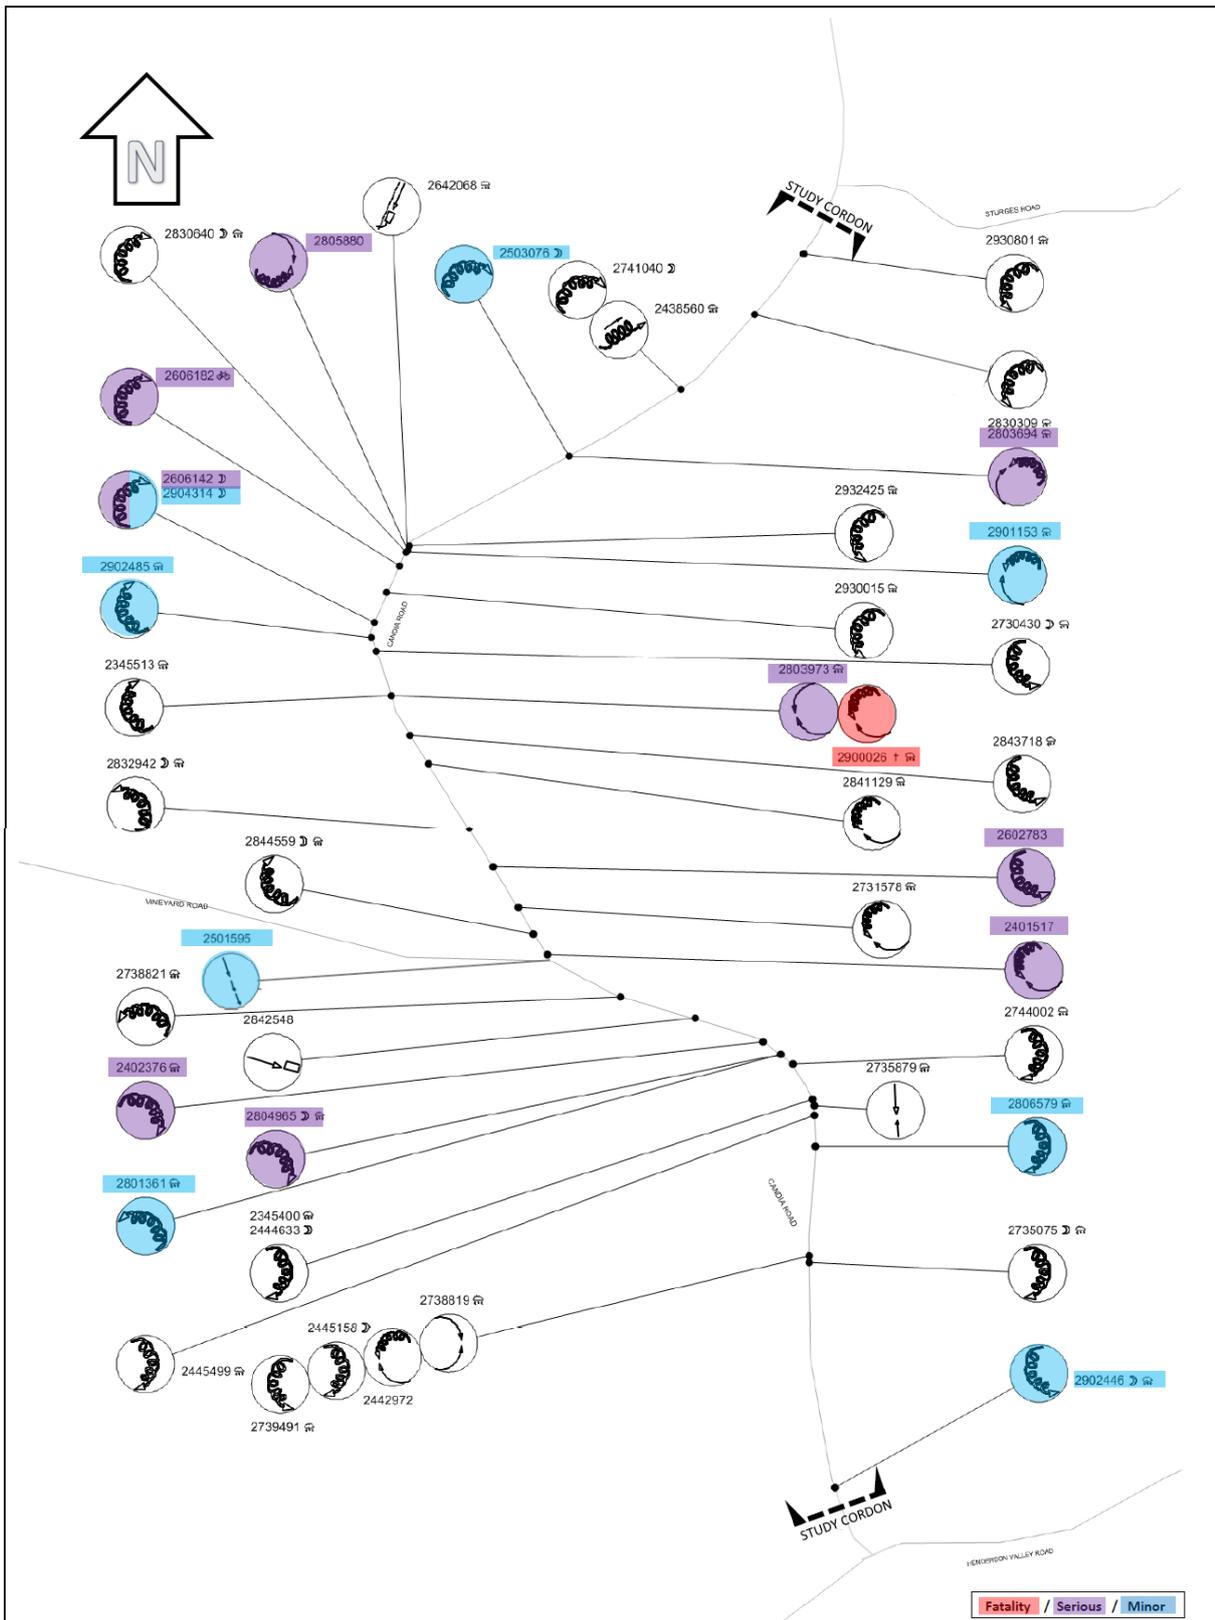
Figure 4 illustrates a crash plot of reported crash statistics ‘before’ the crash remedial measures were installed. The position of most crashes has not been edited, and the crashes appear to be distributed along the entire route.

Figure 4: NZTA CAS Plot (edited) for Candia Road – All Reported Crashes 2003 – 2009. In total, 45 reported crashes over seven years, including 1 fatality, 9 serious injury, and 8 minor injury crashes. Crashes plotted along the route, similar to the original crash plot

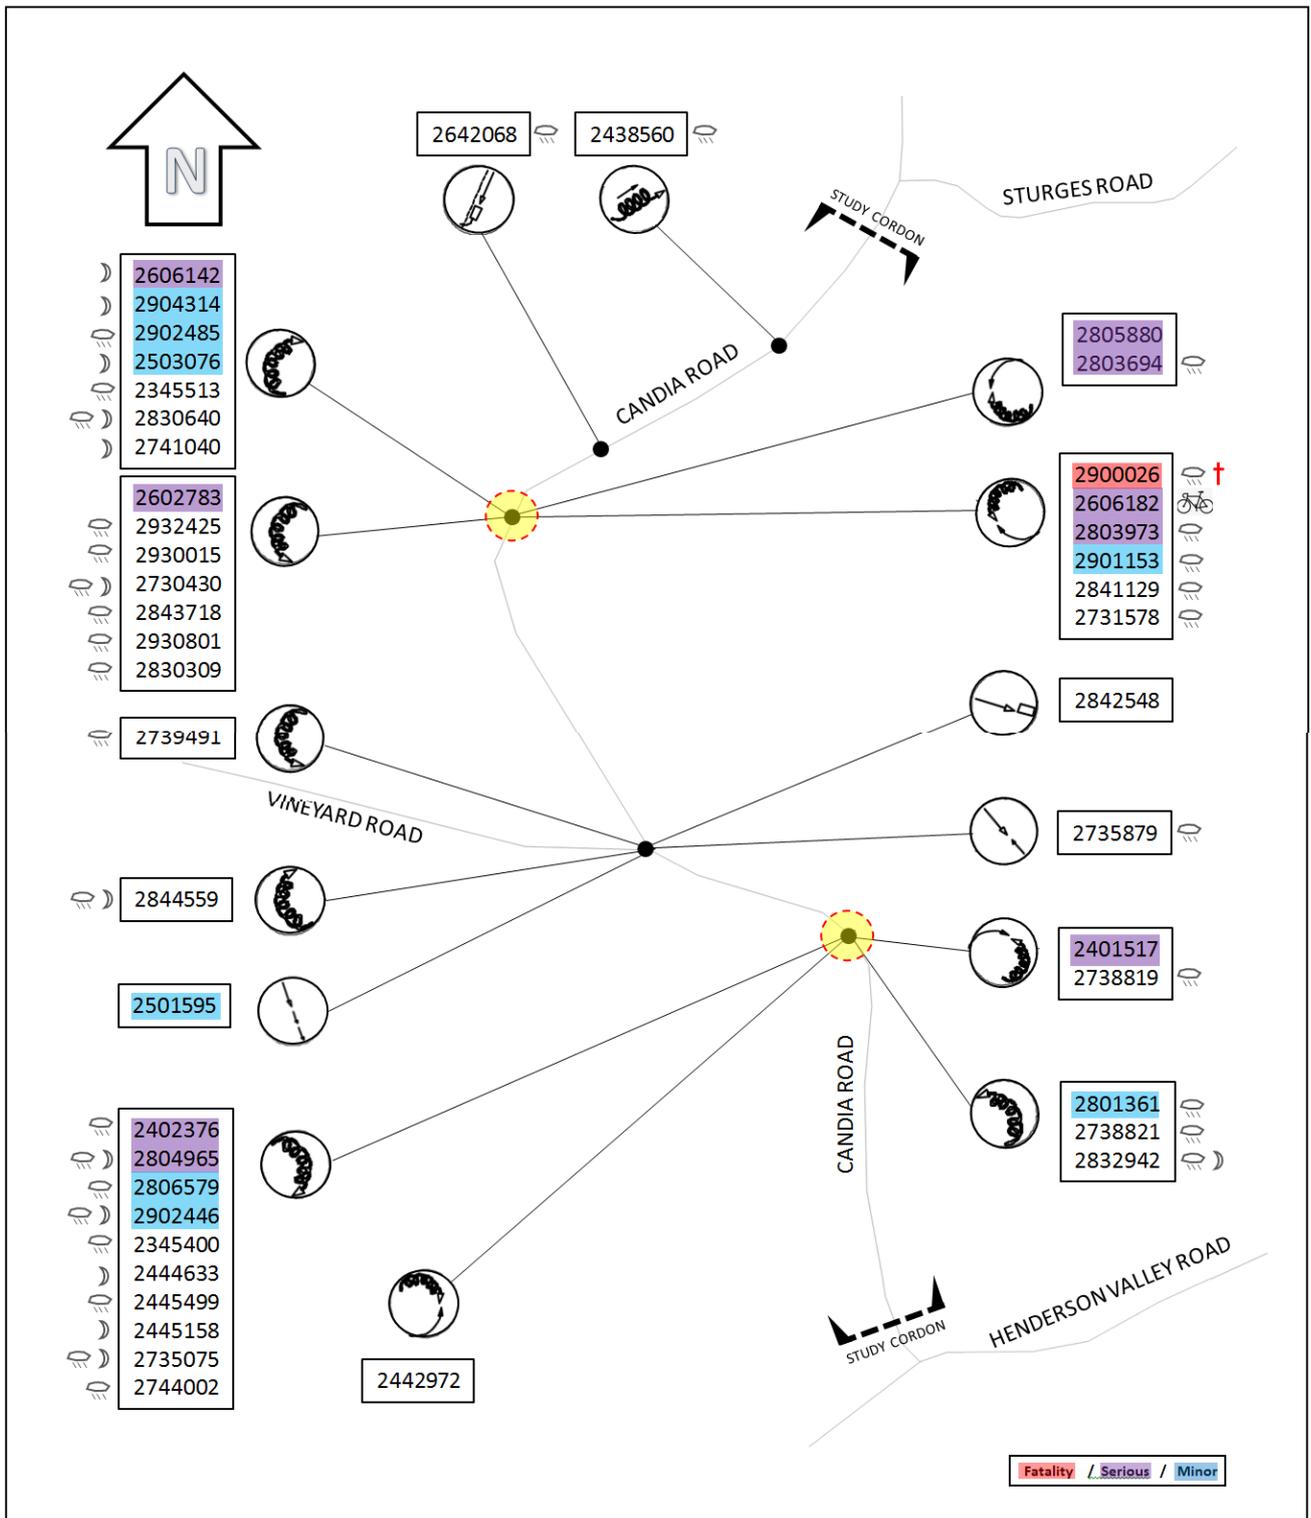
Figure 5 illustrates the same crashes as Figure 4, but Traffic Crash Reports have been analysed in detail and the exact nature, position and direction of each crash re-plotted. Correct interpretation of Traffic Crash Reports can require significant experience and technical expertise. This further analysis results in crash patterns being much stronger and more evident. This enables the causal factors to be identified more accurately, and any proposed remedial works to be focussed on the main issues.

- 45 reported crashes over 7 years, including 1 fatality, 9 serious, and 8 minor injury
- 32 crashes in wet conditions (71%) ☔
- 13 crashes at night (29%) 🌙
- 1 vulnerable road user crash 🚲

Figure 5: NZTA CAS Plot (edited) for Candia Road – All Reported Crashes 2003 – 2009. In total, 45 reported crashes over seven years, including 1 fatality, 9 serious injury, and 8 minor injury crashes. Traffic Crash Reports analysed and crashes re-plotted and grouped accurately

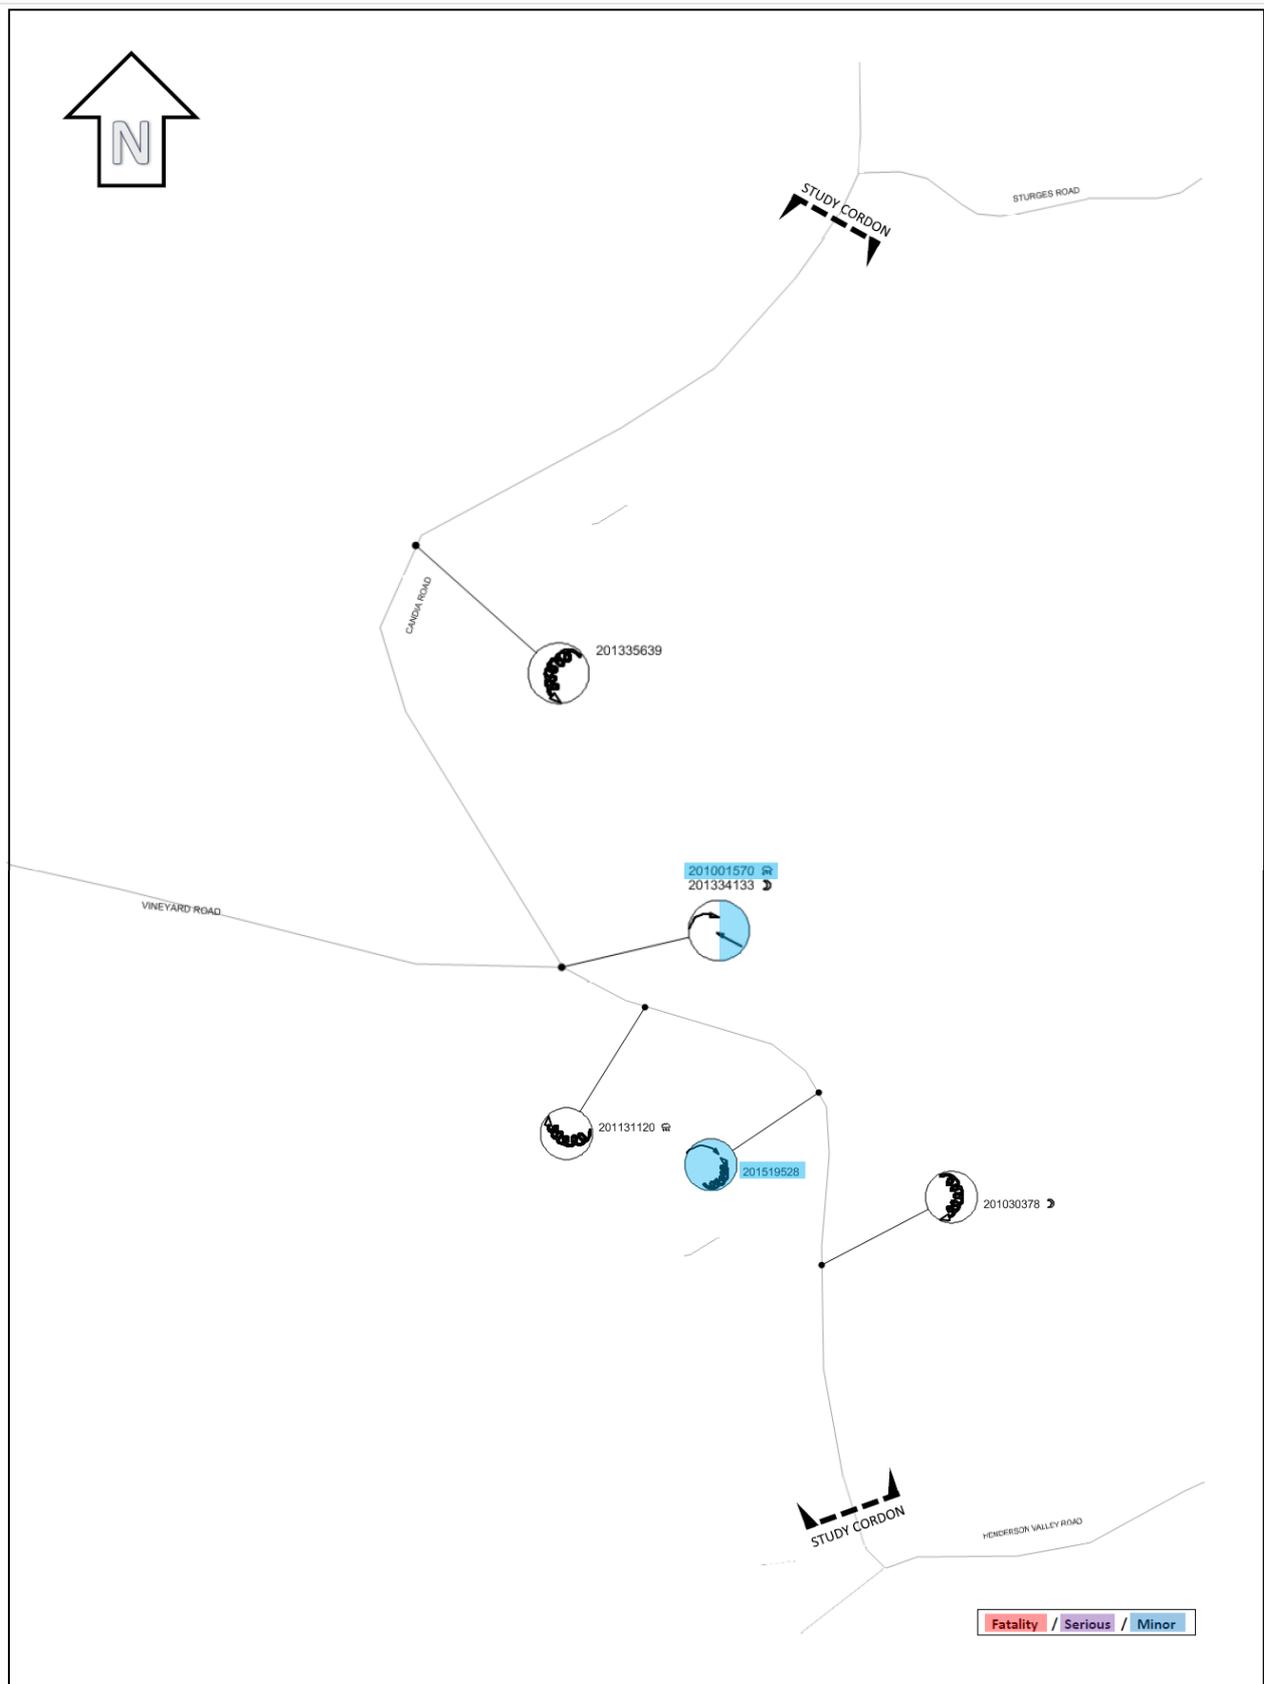
Figure 6 illustrates a crash plot of reported crash statistics ‘after’ the crash remedial measures were installed. In this case the Traffic Crash Reports were not analysed for accuracy of the crashes’ positions and directions, as it is evident that there have been significant crash savings achieved, and the exact nature of the crash patterns are less relevant at this stage of the analysis.

Figure 6: NZTA CAS Plot (edited) for Candia Road – All Reported Crashes 2010 – 2016. In total, 6 reported crashes over seven years, including 2 minor injury crashes. These crashes are in the locations provided by the NZTA Crash Analysis System.
