A Crash Testing Evaluation to Prevent Injuries and Fatalities by Mitigating Vehicle Windscreen Spearing Risk from Road Signs

Nilindu Muthubandara¹, Melvin Eveleigh², Loretta Kung³, John Spathonis⁴

^{1,2}*Centre for Road Safety, Transport for New South Wales, Sydney*

^{3,4}*Queensland Department of Transport and Main Roads, Brisbane, Australia*

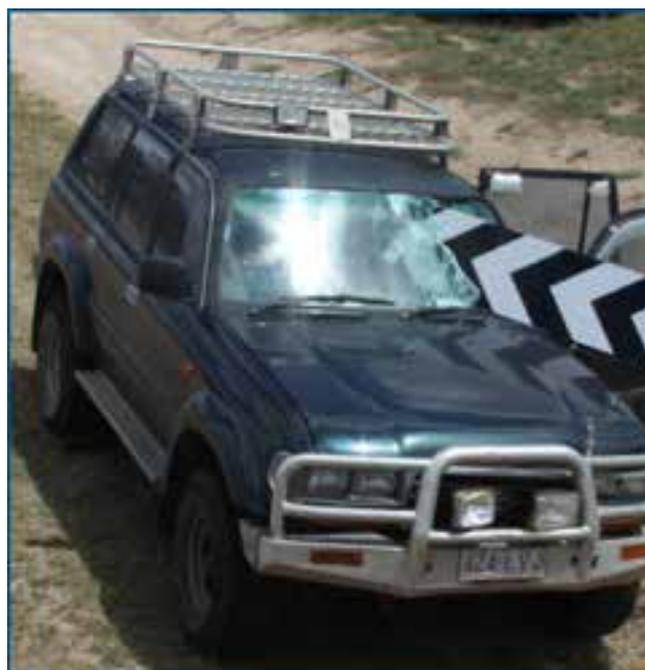
For a particular crash involving a fatality, the road terrain was flat and the through leg had a slight bend. The distance from the road surface to the bottom of the sign was 1500mm. The vehicle involved was a four wheel drive and the distance from the road surface to the engine bonnet surface was approximately 1500mm. The traffic sign speared through the windscreen and entered the occupant space — refer to Figure 1. Despite the sign being installed according to the required standard, it was struck in such a way that it became a road side hazard, penetrated the vehicle and possibly injured the occupant - an unintended consequence of the design and placement. Moreover, end on crashes with signs set at a lower height showed that they have the ability to slice and spear through the body panels of motor vehicles. Early in 2016, Queensland Department of Transport and Main Roads and Transport for New South Wales began a joint research program into the issue of end on collisions with sight boards. The project team drew upon input from a range of specialists from both agencies and industries in Queensland and New South Wales.

Figure 1. Sign spearing incident

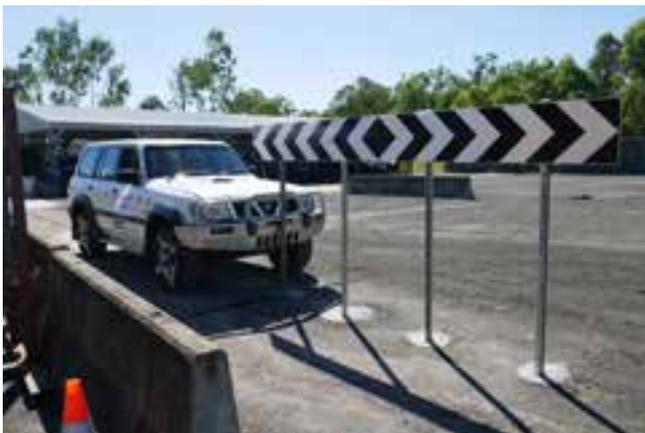
Test 1 (baseline) - This was a baseline test of a standard sight board sign with a four post configuration. Upon impact the pop rivets easily sheared and the aluminium sign face crumpled but did not significantly enter the occupant space as it impacted the metal roof line above the windscreen. However, the Type 1 stiffener rails became detached and acted as spears. The top stiffener rail travelled over the top of the vehicle cabin. The bottom stiffener rail pierced the windscreen into the vehicle compartment in the general area of the passenger's head, continuing on past the seat, hitting the rear passenger side window. Figure 2 shows the damage

from the collision and the high likelihood of a fatal outcome to the occupant in the front passenger seat (and possibly the rear left hand side seat).

Figure 2. Test 1 – sign layout & vehicle damage after crash

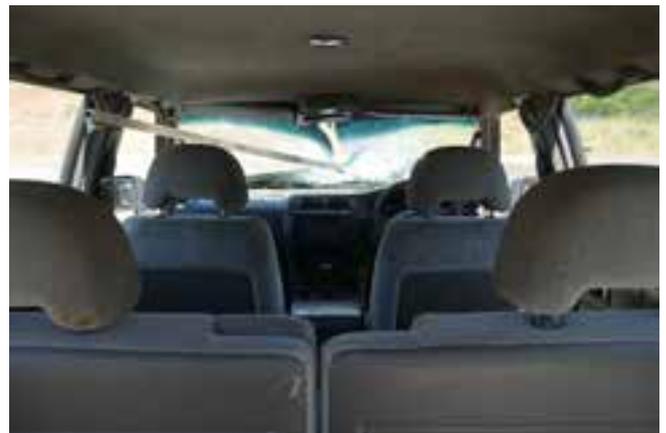
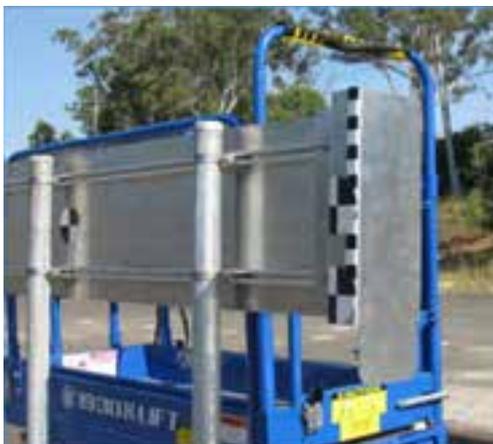
Test 2 (aluminium wrap sign end) — It became evident from Test 1 that not only does the sign face present a danger but also the aluminum stiffener rails. In Test 2 the front of the sign was encapsulated with 3mm aluminum sheet to tie the sign face and stiffener rails together as one unit. A deflector plate was incorporated into the bottom of this plate —refers to Figure 3.

Figure 3. Test 2 - sign end reinforcement

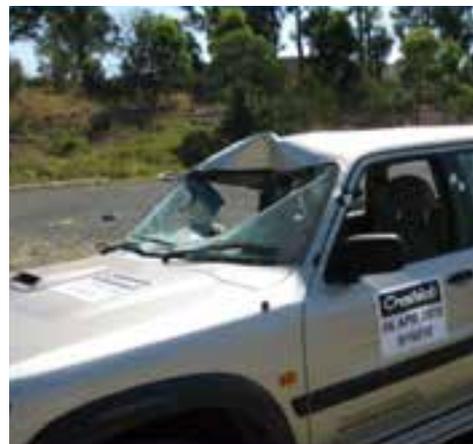
The encapsulating plate added strength to the front of the sign which resulted in more damage to the vehicle roofline above the windscreen — refer to Figure 4. After Test 1 and 2, it was thought that the inertial forces were so significant that a windscreen could not develop enough resistance to deflect a sign over the vehicle. Even with the sign end having a special energy absorbing treatment and the impact area increased, windscreen damage was likely. When a crash occurs and the first post is bent out of the way, the remaining posts downstream hold the sign horizontally and provide restraining forces. Hence if a windscreen were to deflect a sign, it must overcome the sign's high inertial forces and the horizontal and vertical restraining forces provided by the intact posts.

Figure 4. Test 2 - significant vehicle damage

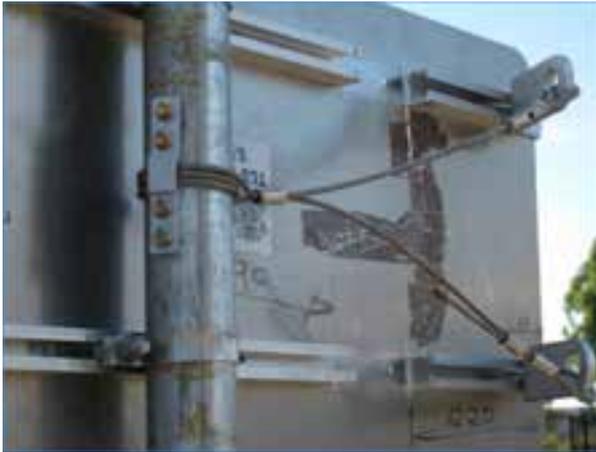
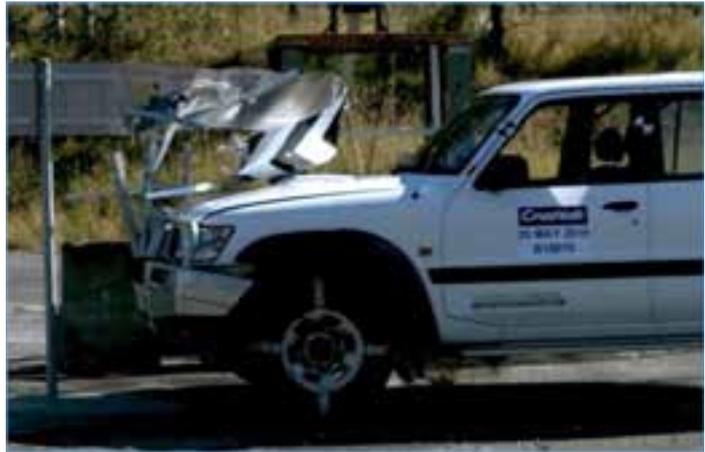
Figure 5. Test 3 – left - cut rails & stainless rope tether, right- successful crash deflection crash

Test 3 (tethered with 5mm cable) — The leading edge of the sign was tethered to the first steel post with 5mm diameter stainless steel wire rope — refer to Figure 5. The stiffener rails were weakened at strategic points. The concept was for the post to pull the sign down and away from the windscreen. The test was a success but the field swaging of the stainless steel was considered to be time consuming. The field cutting of the stiffener rails was performed with a small battery powered circular saw fitted with an aluminum cutting blade. However it was difficult to saw cut the stiffener rails without cutting through the sign face was. Cutting the stiffener rails in this test and subsequent tests greatly facilitated the buckling of the sign during the crash.

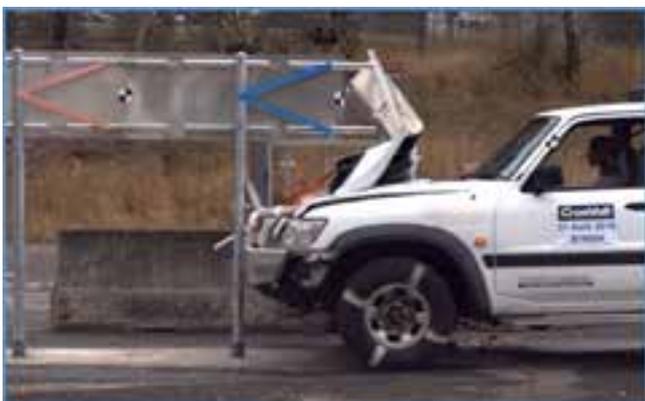
Test 4 (tethered with flat strap & cut rails) — The sign face for this test was significantly larger (6 x 0.6m) hence 65NB posts were used — refer to Figure 6. In this test, the tethered design was refined by replacing the 5mm wire rope with 40mm x 3mm steel flat straps to simplify the field installation. As the sign was comprised of four separate

Figure 6. Test 4 - cut rails & flat straps

aluminum sheets, pull down straps were required to be fitted to each post. The stiffener rails were cut to facilitate failure. As a result of Test 3 learnings, a depth gauge was fitted to the circular saw which made cutting far simpler minimizing the damage to the sign face. This was the only test where the larger modified Type 2A stiffener rails were used.

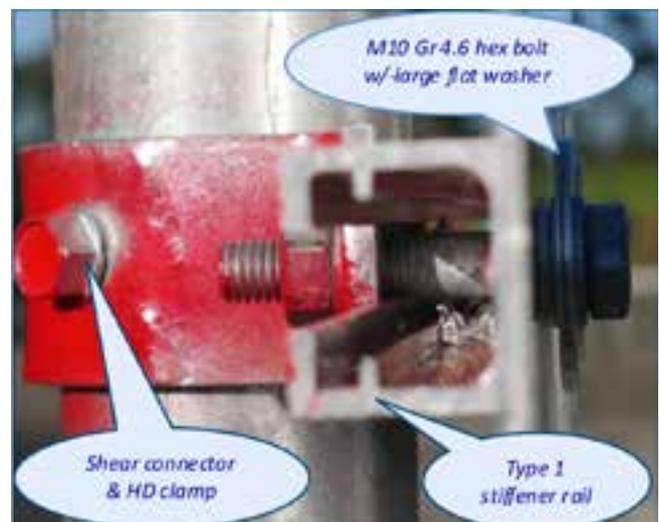
Test 5 (heavy duty clamp & cut rails) — In the development of the project many ideas were explored. One simple approach that was suggested was to fasten the post directly to the sign. This idea was sidelined at the time over a concern that signs with large end cantilevers could pose a risk due to the downward slicing action during initial impact. In Test 5 the relative weak standard sign bracket was replaced with an off-the-shelf heavy duty clamp made from 40mm x 5mm flat steel – refer to Figures 7 & 8.

The clamp was fastened with two M10 bolts which passed through the sign face and stiffener rail. A large flat washer was placed under the head of the bolt to resist it being pulled through the sign face.

Figure 7. Test 5 onward – heavy duty clamps used

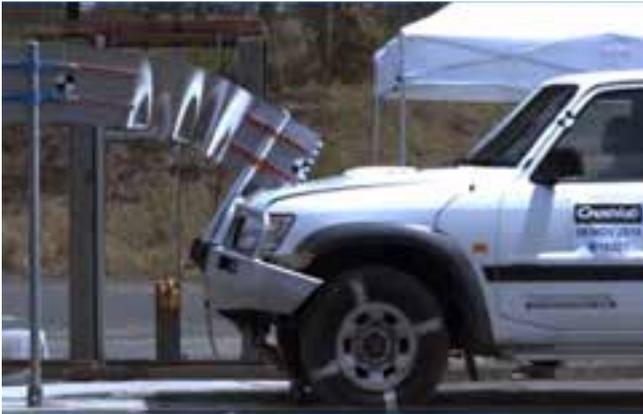
Figure 8. Test 5 - Shortened rails & HD anchored clamps

Test 6 (heavy duty clamp & cut rails) — This test was identical to Test 5 with the exception that a small passenger vehicle was used in lieu of a four wheel drive – refer to Figure 9. Figure 8 and 9 both show the downward slicing action of the sign. A future consideration for low mounted traffic signs is to limit the sign end cantilever distance. The clamps successfully pulled the sign down to prevent impact with the windscreen. A significant drawback with the design approach in Tests 5 & 6 was it was difficult to install the sign while maintaining a flat front face due to shorter sections of stiffener rail. The heavy duty clamps gripped the posts tightly and would rotate the sign face as each clamping bolt was tightened. The sign installer had to be very diligent to ensure the finished sign face was acceptably flat. The performance of these signs in high wind conditions was an unknown.

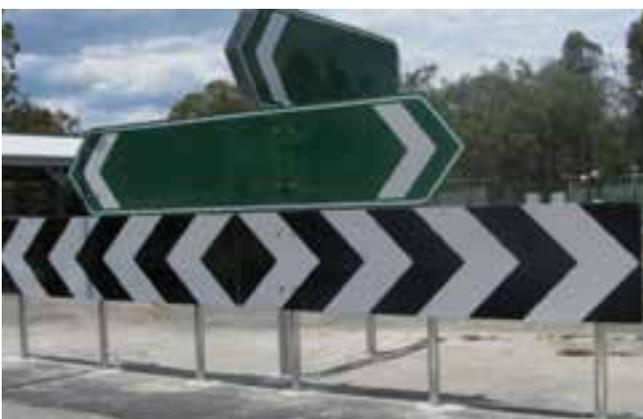
Test 7 (heavy duty clamp & continuous rails) — The test involved a combination of large signs at a typical T intersection with intersection directional signs and a sight board — refer to Figure 10.

Figure 10. Test 7 – large sign structures

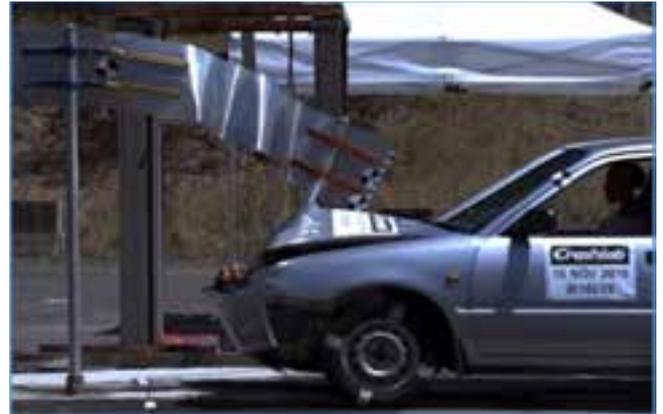
Figure 9. Test 6 - Shortened rails & HD anchored clamps

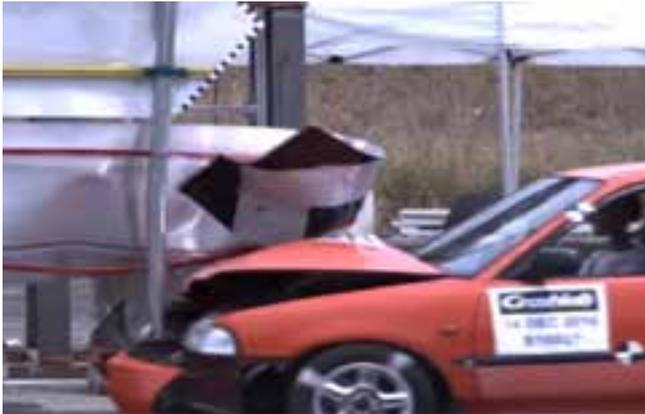
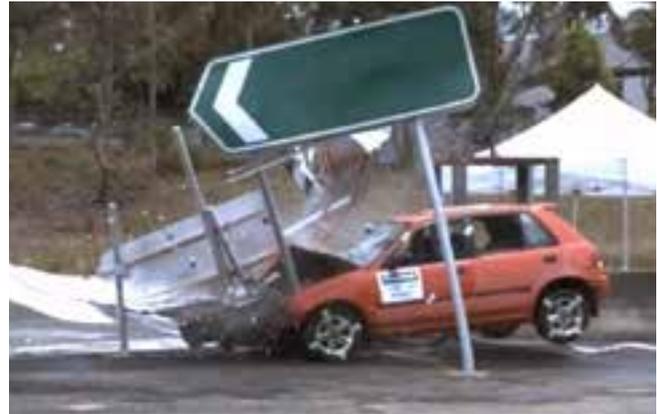
A component of the test was to witness the effect on a small car with crashing into larger diameter posts (65NB & 80NB) – refer to Figure 11. Heavy duty anchored clamps

were employed as per Tests 5 & 6. The design exception was that the longitudinal stiffener rails were not cut. Despite considerable vehicle damage the test was a success.

Figure 11. Test 7 – left-small vehicle on impact, right- large area signs & large posts

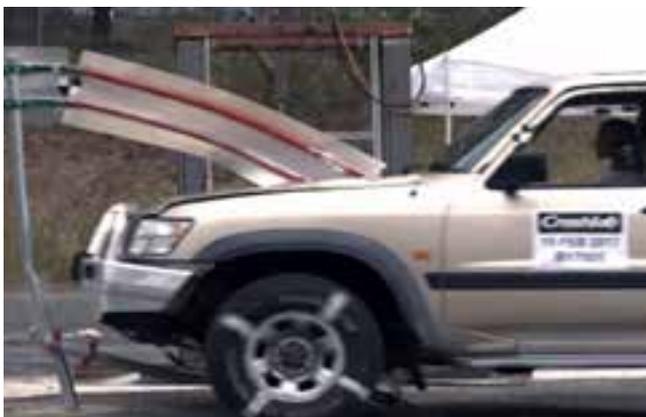
Although the sign did not penetrate the occupant space, Test 8 was not considered to be successful – refer to Figure 12. The high speed video showed the bolts and heavy duty

clamps could not generate enough force to prevent sliding along the stiffener rail. When a large axial and transverse force was applied to the cup head bolts, the channel shaped aluminum stiffener rail bent open allowing the bolt heads to escape. During the initial pulldown, the bottom edge of the sign face had sliced through the vehicle bonnet.

Once the bolts were pulled free of the stiffener rail, the sign continued to slice open the bonnet until it hit a strong bonnet cross member where it was forced to buckle. The additional Henrob rivets placed in the vicinity of the posts stiffened the sign further which worsened the situation.

Figure 12. Test 8 – No through bolts and slicing of the bonnet

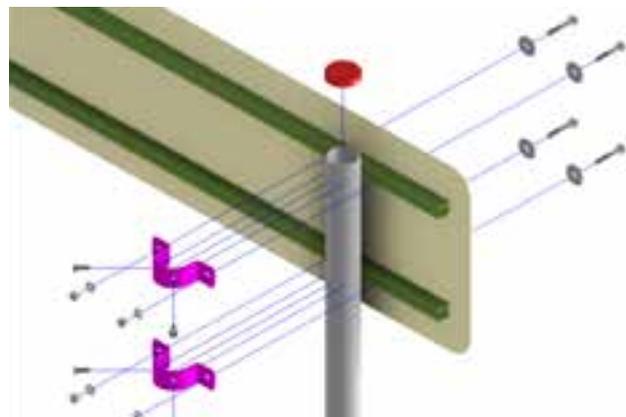
- The heavy duty clamps were bolted through the sign with large diameter washers located under the hexagonal bolt heads on the sign face — refer to Figure 13.
- Two Taptite M8 x 20 hex head screws per clamp were again used.
- The standard spacing of Henrob rivets was adopted (~200mm centers) to streamline manufacturing.
- Type 1 stiffener rails were used.
- Heavy duty clamps were installed on all posts.

Figure 13. Test 9 - HD clamps & bolted through

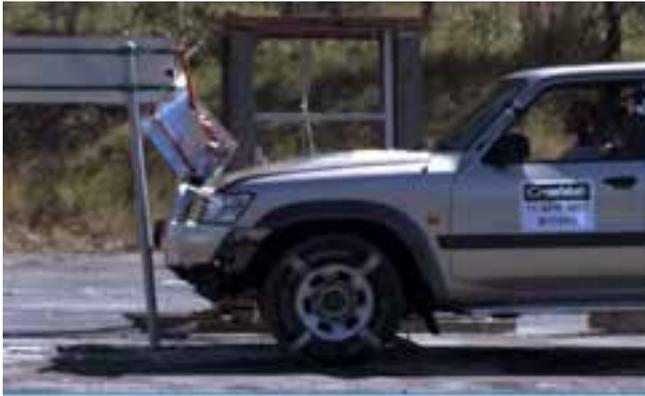
This test was considered a success as the sign buckled at initial impact and was pulled down — refers to Figure 14.

Figure 14. Test 9 – successful pull down

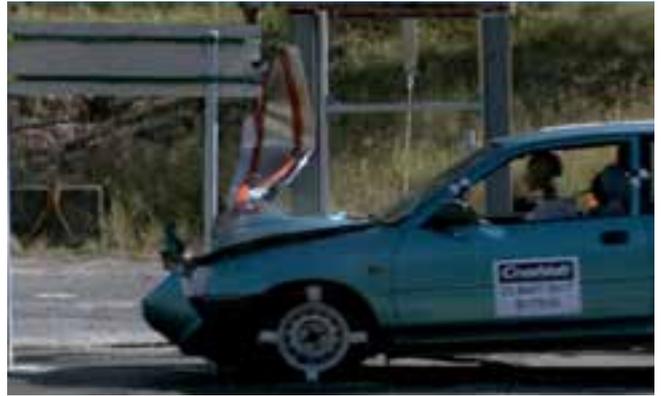
Test 10 — Before the testing program could be declared a success, Test 10 had to confirm that the final design would work with both a large and small passenger vehicle. This test replicated Test 9 with the exception that the test vehicle was a small passenger car — refer to Figure 15. This test was considered a success with only minor windscreen cracks and no sign spearing through the windscreen. During the testing program some minor windscreen cracking occurred through unpredictable hits by deformed sign components.

Figure 15. Test 10 – successful use of HD clamps & bolted through design

The crash testing program has proven that both currently installed and new signs could be successfully treated with the use of heavy duty bolted clamps in combination with shear connectors. High speed vehicle crashes with both four wheel drives and small passenger vehicles have demonstrated that the signs can be prevented from entering the occupant space of the vehicle.

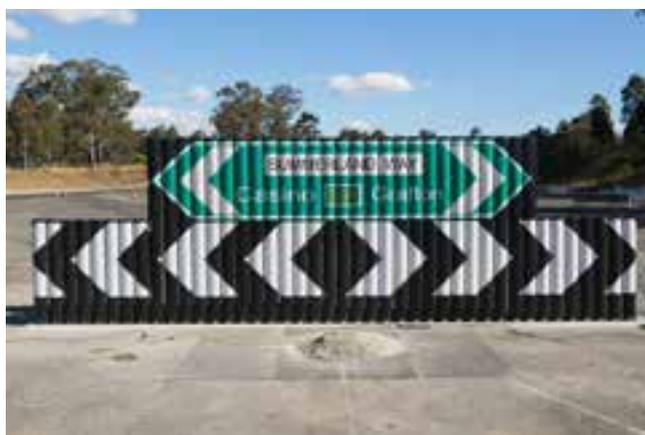
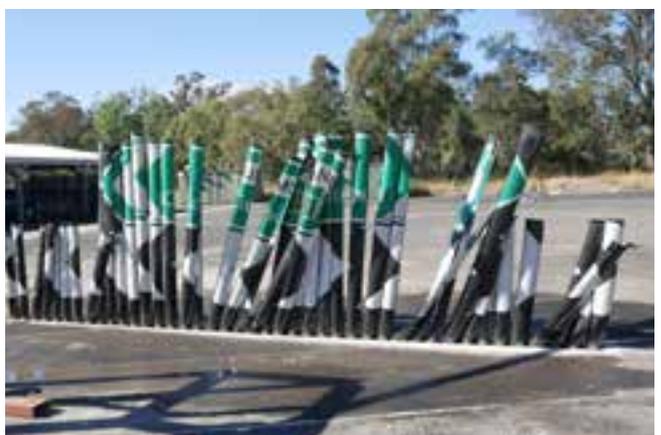
Flexible road signs were investigated as an alternative solution in eliminating the potential of sign spearing under the above tested conditions. These signs offer little

resistance to the colliding object and thereby causing virtually no impact force to be imparted on the vehicle and its occupants or riders. A commercially available product has been tested and was found to require complete replacement after one collision. While this protected the vehicle occupants, the installed sign was prohibitively expensive. Its application would not address the vast number of existing signs that require treatment. Therefore the replacement of traffic signs with flexible “plastic” signs is not considered as an alternative approach.

Figure 16. Testing of flexible signs
