FULL CRASH TEST RECONSTRUCTION AND ANALYSIS OF FOUR REAL-WORLD IMPACTS

Melanie Franklyn, David Logan, Peter Hillard and Brian Fildes
Monash University Accident Research Centre (MUARC), Victoria, Australia.

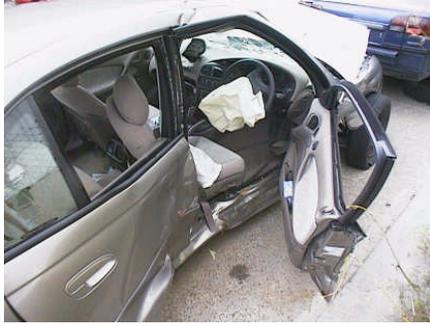
A 1993 small coupè (bullet vehicle) struck a large passenger sedan (target vehicle) on the driver's side (right) after running a red light. The target vehicle rotated almost 180 degrees clockwise and then impacted a pole at the front of the vehicle on the passenger's side (left). The secondary pole impact was not reconstructed because the injuries to the occupants in the target vehicle were attributed to the primary impact. There were two occupants seated in the target vehicle: a male driver (the case occupant) and a female front seat passenger (FSP). The male occupant was 56 years old, 1.79m and 80kg while the female occupant was 51 years old, 1.59m and 65kg. Both occupants were wearing seatbelts. Frontal and side airbags were fitted to the vehicle and both airbags deployed in the crash. The only occupant of the bullet vehicle was the driver, who was female. Medical details pertaining to the driver of the bullet vehicle were not collected as she was not recruited into the study. Figures 1a to 1c show the real-world vehicles.

(a) Case 1: Target vehicle showing the lateral impact.

The CDC for the real-world and crash test target vehicles were identical, indicating that the damage produced in the crash test was a reasonable outcome. A comparison of damage measures (e.g. maximum crush depth and Energy) indicates that, for the target vehicle, the crash test damage slightly underestimated the real-world crash damage. The damage profile from the crash test was slightly wider and the maximum crush was further towards the rear of the vehicle compared to the real-world impact (when comparing C3 and C4). A similar analysis of the bullet vehicle shows that the damage produced in the crash test was somewhat greater than in the real-world case, but the accuracy of the damage profile for the bullet vehicle was not as important as that of the target vehicle. Overall, the crash test appeared to be a reasonable representation of the real-world crash.

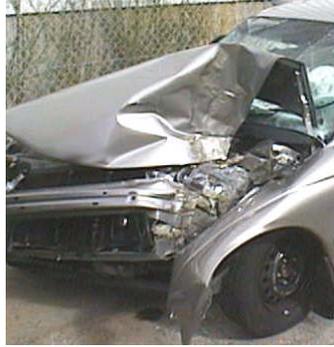
(b) Case 1: Target vehicle showing pole impact.

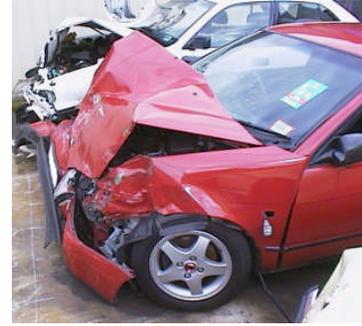
(c) Case 1: Bullet vehicle.

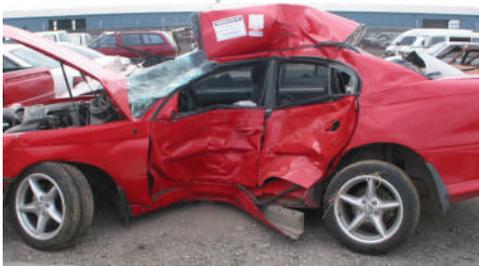
(d) Case 2: Target vehicle.

The driver of a large passenger sedan lost control of his vehicle on a bend in the road and hit a tree on the passenger's side (left). The vehicle is shown in Figure 1d while the tree is shown in Figure 1e. The only occupant of the vehicle was the driver, who was 46 years old, 178cm in height and weighed 95kg. He was wearing a seatbelt at the time of the crash. Three airbags were

The C1-C6 measurements show that the maximum amount of lateral intrusion in the crash test (135cm) was slightly more than the maximum amount of lateral intrusion resulting from the real-world crash (101cm). The resulting BEV and energy values produced from the crash test vehicle were also greater than in the real-world crash. This was due to both the maximum lateral intrusion and the direct damage width being greater in the crash test vehicle than in the real-world case vehicle. In summary, the crash appeared to be a reasonable representation of the real-world crash.

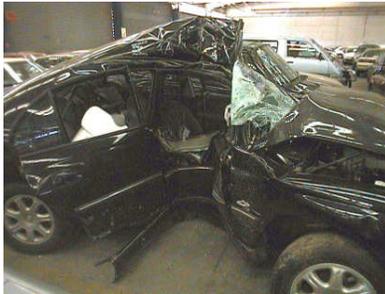
(f) Case 3: Target vehicle.

The driver of a large passenger sedan lost control of his vehicle and clipped a parked vehicle on the front passenger side (left). He then struck a telegraph pole on the driver's side (right), which resulted in extensive cabin intrusion. Only the second collision was reconstructed as the injuries sustained were attributed to the impact with the pole. There were two occupants in the vehicle, a driver and a FSP. The driver, who was the case occupant, was a 39-year-old male who was 180cm in height and weighed 80kg. The FSP was a male of similar anthropometric dimensions to the driver. Both occupants were belted. The FSP was admitted to a non-study hospital, hence his injuries could not be recorded. Figure 1f shows the real-world vehicle, and Figure 1g the pole.

A comparison of the CDC values from both the real-world case (03RPAW5 right-hand drive) and the reconstructed case (09LPAW4 left hand drive) indicates that the deformation profile was similar. Although the CDC profile produced was alike, the crash test damage somewhat underestimated the real-world crash damage, which was evident when comparing parameters such as the BEV, the Energy, the direct damage width and the C1-C6 measurements.

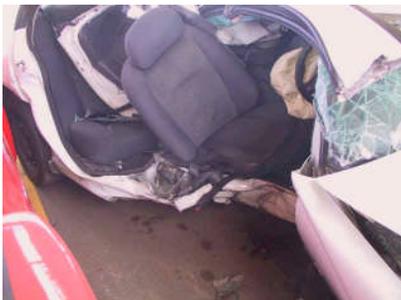
(h) Case 4: Target vehicle.

The driver of a large passenger sedan lost control of his vehicle while travelling on a freeway and subsequently hit a road sign pole on the side of the freeway. The driver, an 18-year-old male, was the sole occupant. He was 190cm tall and weighed 73kg, and was belted at the time of the crash. The real-world vehicle is shown in Figure 1h, while Figure 1i demonstrates the road sign pole.

The final crash test speed chosen was 58km/hr and no crab angle was used (Figure 2d). As the pole was an unusual shape (Figure 1h), an identical pole was obtained through the subcontractor who assembled the original poles. A 50th percentile BioSID ATD was used to represent the driver. There were 56 data channels attached to the ATD, and airbag and pretensioner fire times were recorded. The vehicle damage is shown in Figure 1g.

A comparison of the results shows that the crash test appears to be a good representation of the real-world crash, as the BEV and Energy were close in both cases. The maximum intrusion was greater in the crash test vehicle than the real-world vehicle, but the BEV was slightly greater in the real-world vehicle as the damage spanned a greater length of the vehicle.

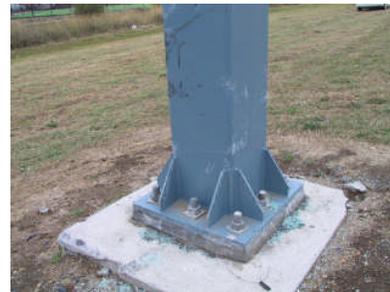
(i) Case 4: Base of the road sign pole.

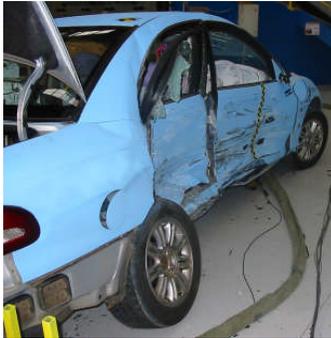
The required pre-impact crash test speed was computed to be 85km/hr, but as the winch was manually operated, the final crash test speed attained was 85.74km/hr. The pre-calculated crab angles needed were 43 degrees for the target vehicle and 47 degrees for the bullet vehicle – this double crab configuration was used as the crab angle was too large to replicate at the test facility. In order to generate the crab angle, the bullet vehicle was mounted onto a trolley. To compensate for the trolley mass of 200kg, an equivalent mass of vehicle components were removed from the bullet vehicle such that the position of the centre of gravity was not altered. Both on and off-board cameras recorded the motion of the vehicle and the ATD's. The crash test configuration is shown in Figure 2a. To represent the two occupants in the target vehicle, the ATD's used were a 50th percentile BioSID for the driver and a SIDII for the FSP. There were 50 data channels for the BioSID, while the SIDII had 26 channels. The Hybrid III in the bullet vehicle was not instrumented as the injuries to the real-world occupant of the bullet vehicle had not been documented. A total of 9 contact switches was installed and airbag and pretensioner fire times were recorded. In total, 101 channels were used for the crash reconstruction. Figures 3a and 3b show the damage to the crash test vehicles.

(a) Case 1: Target vehicle showing the lateral impact

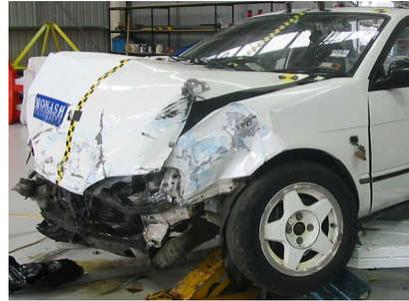
(b) Case 1: Bullet vehicle

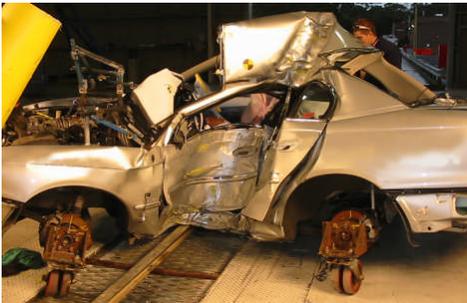
The final crash test speed was 61.02km/hr, and no crab angle was used (Figure 2b). The reconstruction involved towing the vehicle into a specially designed pole (Figure 3d), which was angled to represent both the angle of the tree and the angle the vehicle adopted at the final rest position due to the topography of the ground. A 50th percentile BioSID ATD was used to represent the driver. There were 54 data channels attached to the ATD, two contact switches were instrumented and airbag and pretensioner fire times were recorded, making a total of 62 channels. Figure 3c demonstrates the damage to crash test vehicle.

(c) Case 2: Target vehicle

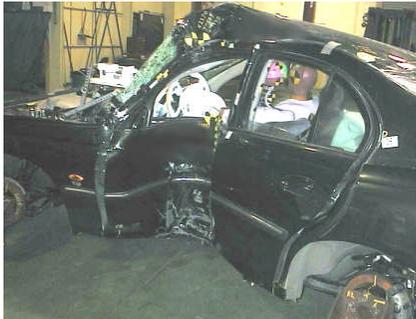
occupants and 5 contact switches were used. Airbag and pretensioner fire times were recorded. A total of 57 channels was used for the entire crash test. The post-test damage can be observed in Figure 3e.

(e) Case 3: Target vehicle.

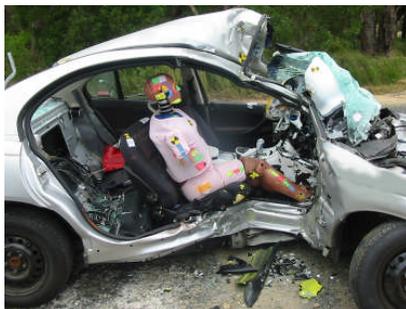
(g) Case 4: Target vehicle.

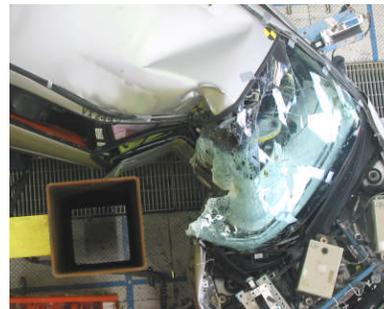
(h) Case 4: Pole with post-crashed vehicle.
