The Adelaide Metropolitan Indepth Crash Investigation Study 2002-2005

Woolley, J., Kloeden, C., Lindsay, T, Ponte G & McLean J
Centre for Automotive Safety Research, The University of Adelaide

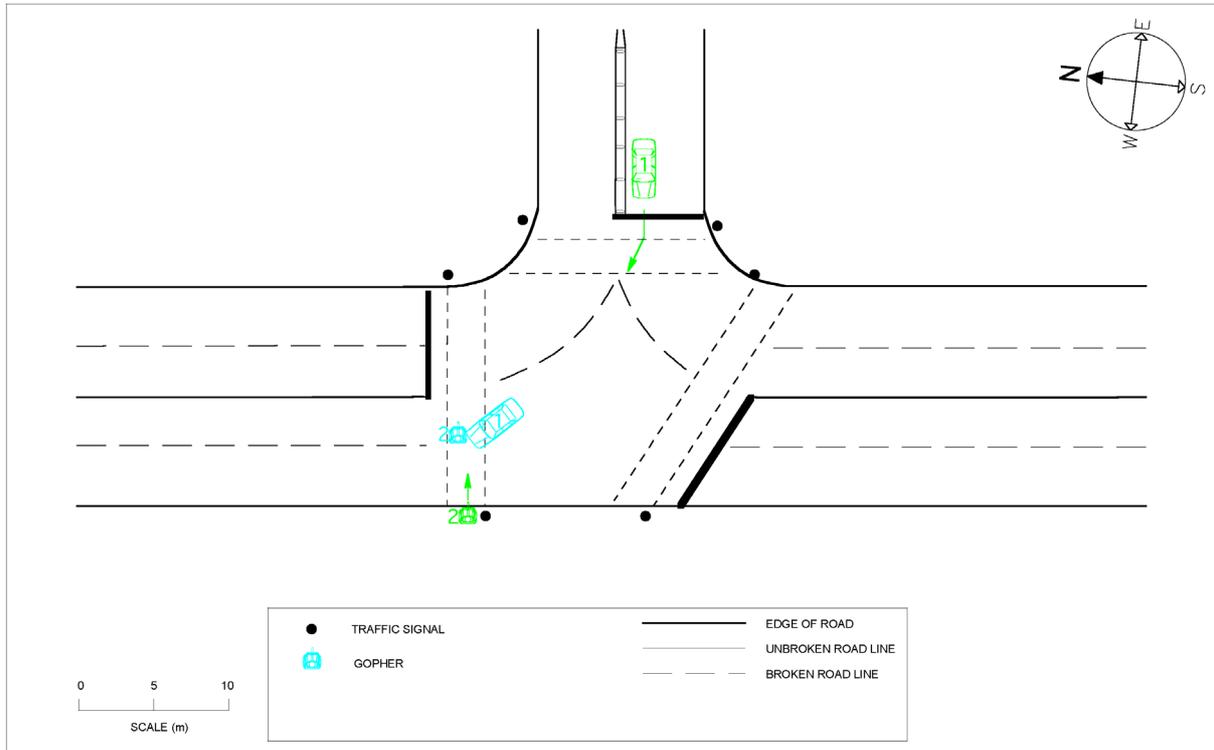
A case investigated involved the collision of a right turning car with a motorised wheelchair (also known as a gopher or scooter) crossing at a signalised T-junction. A plan of the site, which has a slightly unusual geometry, is shown in Figure 1.

Figure 1 – Site plan showing the movements of the right turning vehicle and the gopher

Given the presence of sun glare, the common misinterpretation of the right turn signal and the fact that pedestrians on the crossing cannot be seen by drivers in such circumstances, a totally different solution is required. It appears that a dedicated pedestrian crossing phase should be introduced (commonly referred to as a "Barne's Dance" or "scramble" crossing). That would cause some additional delay to motorists but would have the advantage of separating simultaneous conflicting movements of pedestrians and vehicles.

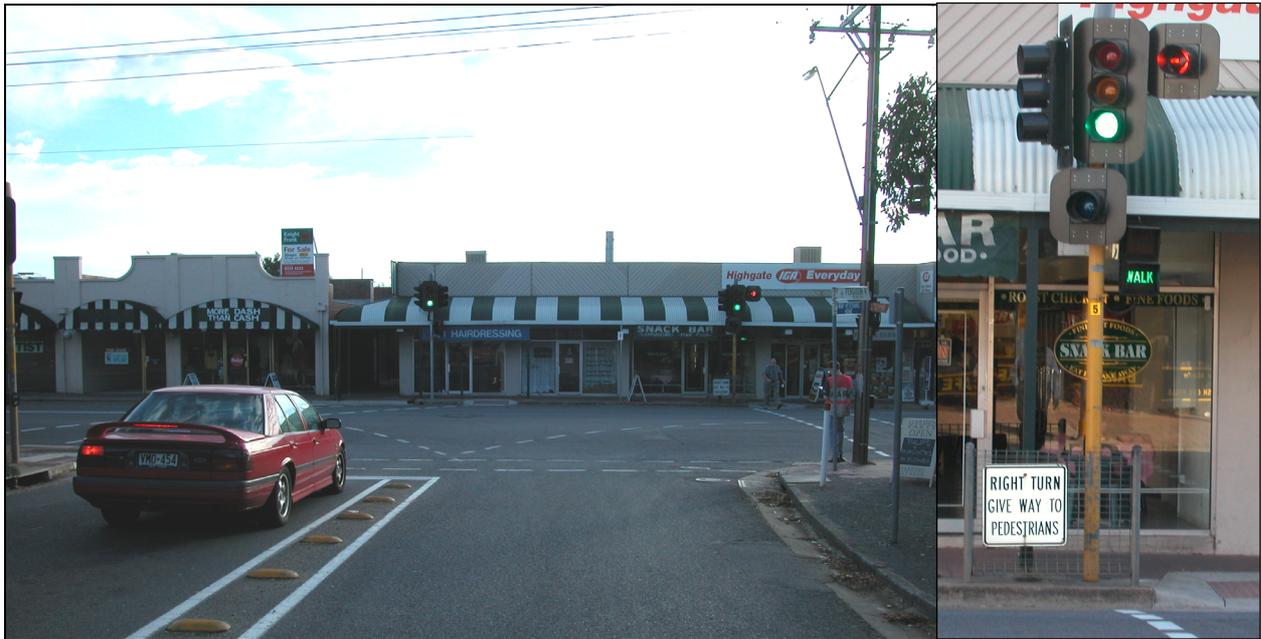
The view of the junction from the perspective of the driver of the vehicle is shown in Figure 2. Some modifications have been made to the right signal pole in the figure. A right turn arrow signal has been installed in addition to a “Right Turn Give Way to Pedestrians” warning sign and a flashing white signal warning motorists of pedestrians. Clearly these were attempts to address major issues with right turning vehicles interacting with pedestrians at the pedestrian crossing.

Figure 2 – Perspective of right turning driver and close up of the right signal pole

The phasing of the signals is such that when traffic from the side street is given a green light (in the form of a green orb), pedestrians are also shown the green walk signal. However, right turning vehicles are also shown a single red turn arrow which extinguishes a few seconds after the pedestrian walk signal is given. On this occasion, a vehicle pulled out of the side street to turn right and struck the gopher which had entered the pedestrian crossing, as shown in Figure 1. The gopher driver sustained contusions and abrasions to the right elbow and leg, and an abrasion to the left side of the chest and was taken to hospital for treatment.

CASR observations at the site revealed that turning through the red arrow was a common occurrence and motorists who stop for red arrows are often abused by following drivers for not proceeding. Discussions with local business owners indicated that this type of incident was commonplace.

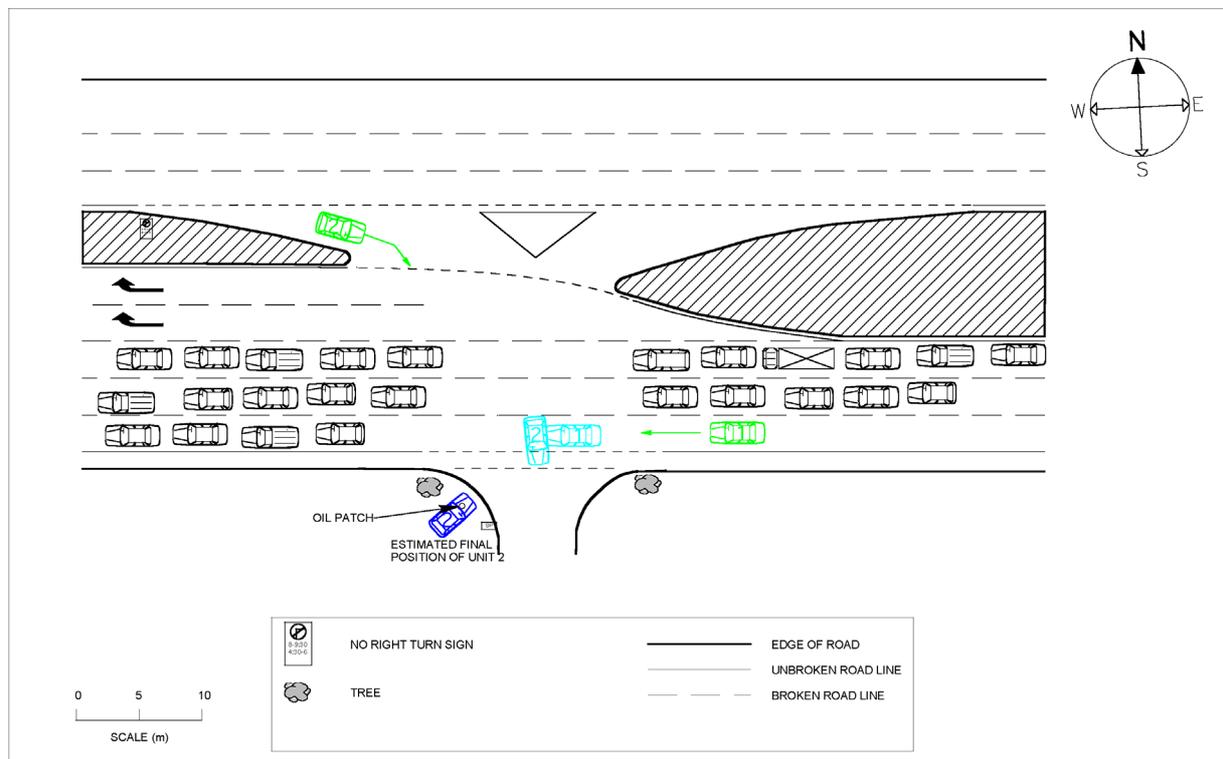
A major three lane arterial road in Adelaide frequently encounters congestion and queuing traffic at peak times. Two cases investigated by CASR have involved vehicles turning across gaps in these queues to access side streets. Follow up interviews indicated that in each case the turning drivers were waved through by other drivers stationary in the queue. A site diagram for one of the crashes is shown in Figure 3.

Figure 3 – Site diagram showing the right turn and through vehicle manoeuvres leading to the collision

It is evident that the combination of queuing traffic adjacent to uncongested lanes and the practice of courteous drivers waving turning drivers through was contributing to crashes. A study of the TARS database for the section of road upstream and downstream of the two collision sites revealed a high number of right turn and right angle collisions. Although there are signs at some locations prohibiting right hand turns into side streets during peak periods, many such crashes still occur. Table 3 outlines the crash incidence along a 3.5 km section of the road.

In some cases the number of right turn and right angle crashes at the local road T-junctions outnumbers those at the major signalised junctions. Furthermore, crash severity is disproportionately higher at these junctions when compared to the metropolitan area as a whole. The time at which the majority of these crashes occurred indicated that the problem was mainly associated with the morning and late afternoon/evening peak periods, the time during which such manoeuvres are prohibited. Although enforcement could be targeted at these sites, it is unlikely to provide a permanent solution. Closing off the road to right turners would eliminate the crash risk at these sites but that may not be an acceptable solution. Introduction of legislation prohibiting overtaking stationary vehicles on the left may provide a partial solution, as is the case on British motorways.

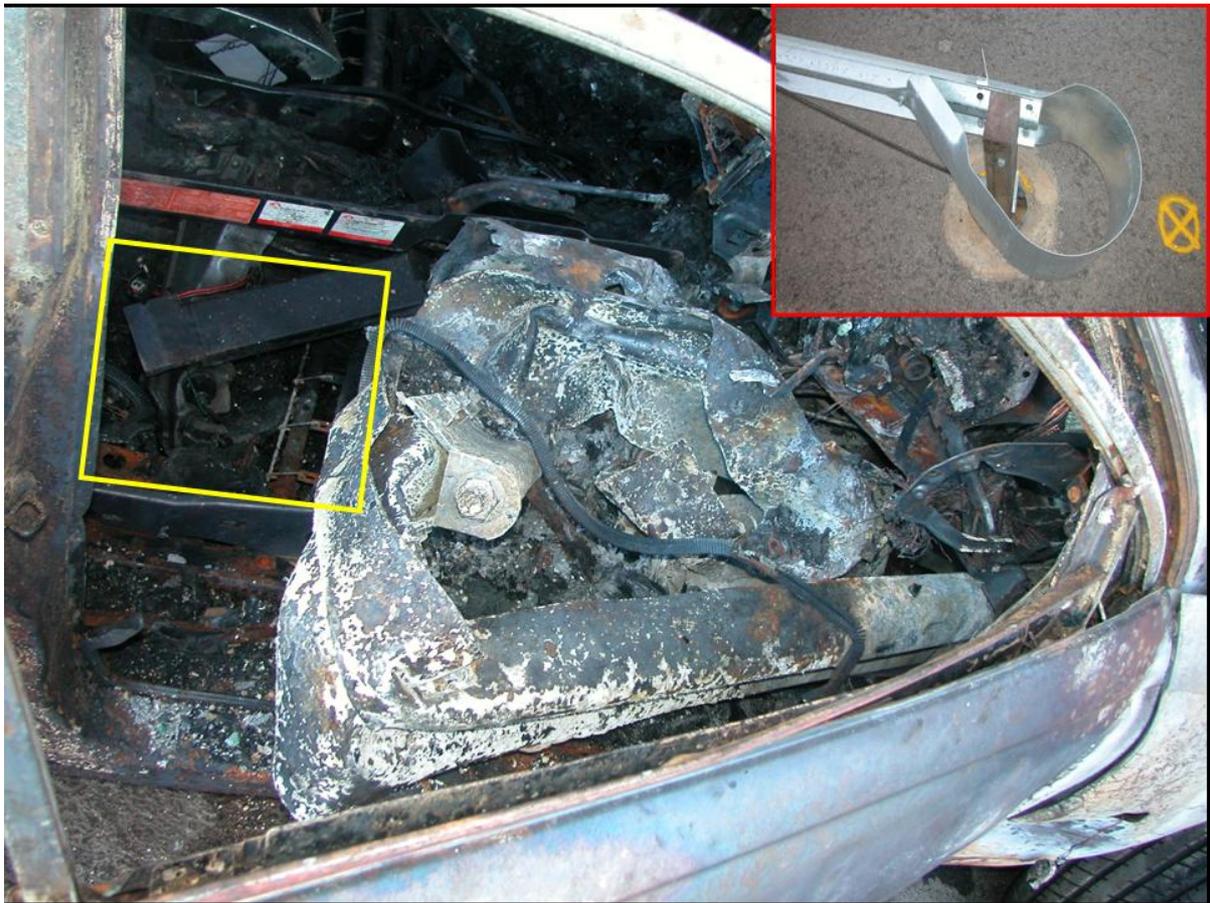
On a weekday afternoon, a 1999 Holden Statesman was travelling on a multilane road in the kerbside lane in a 70 km/h zone. The vehicle failed to negotiate a slight right hand bend and struck the end of a section of Armco guardrail installed to protect motorists from an overhead signal gantry. The guardrail section was fitted with a gating drum end terminal consisting of a tensioning wire rope and two wooden break away posts (Figure 4). Upon impact the Armco speared into the vehicle, through the engine firewall and into the driver's compartment. The driver, who was the sole occupant of the vehicle, was pinned by his legs with his upper torso over the front passenger's seat. A small fire started which soon engulfed the vehicle, killing the driver. Bystanders tried in vain to extract the injured driver and put out the fire.

Figure 4 – Photo showing the terminal end section of the guardrail intruding into the driver's compartment. The square to the left shows the burnt out remains of the driver's seat. The inset to the right shows the type of terminal end used.

The guard rail was installed to current standards but despite this it is evident that the terminal end performed inadequately. Through routine maintenance, the sections of guardrail were repaired and replaced with exactly the same terminal end treatment. In such cases, the TARS crash database is unlikely to be useful in identifying collisions with guard rails let alone terminal ends. No feedback is obtained from maintenance crews and so it is unlikely that follow up assessment is conducted by road authorities. In depth investigation was instrumental in demonstrating the deficiency of the treatment and has highlighted the need for the continual monitoring of any new treatments adopted to ensure that they are performing as intended.

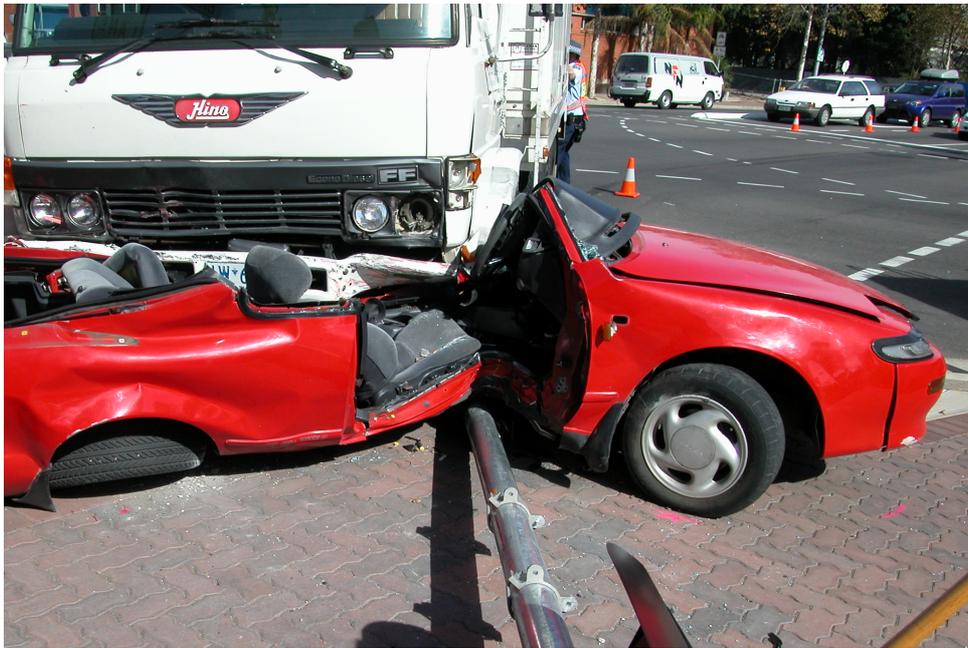
On a weekday afternoon, a driver who was the sole occupant of a vehicle had to conduct a filter right turn at a signalised intersection. The driver entered the intersection and proceeded to turn right (having a green orb signal on display) and was struck by a rigid truck and shunted into a traffic signal pole. Although trapped in the vehicle, the driver only suffered minor cuts and abrasions despite the significant damage to the vehicle (see Figure 5). Follow up interviews revealed that the driver had two jobs which had been causing some stress and fatigue. On the day of the crash, she was called in early to her second job and had less sleep than normal the previous night. She was turning at the intersection to access some shops on her right and looked but did not notice any oncoming vehicles until just prior to impact.

Figure 5 – Damage to the vehicle that collided with a rigid truck showing final resting position and significant intrusion caused by the truck and traffic signal pole (emergency services have removed the roof of the vehicle)

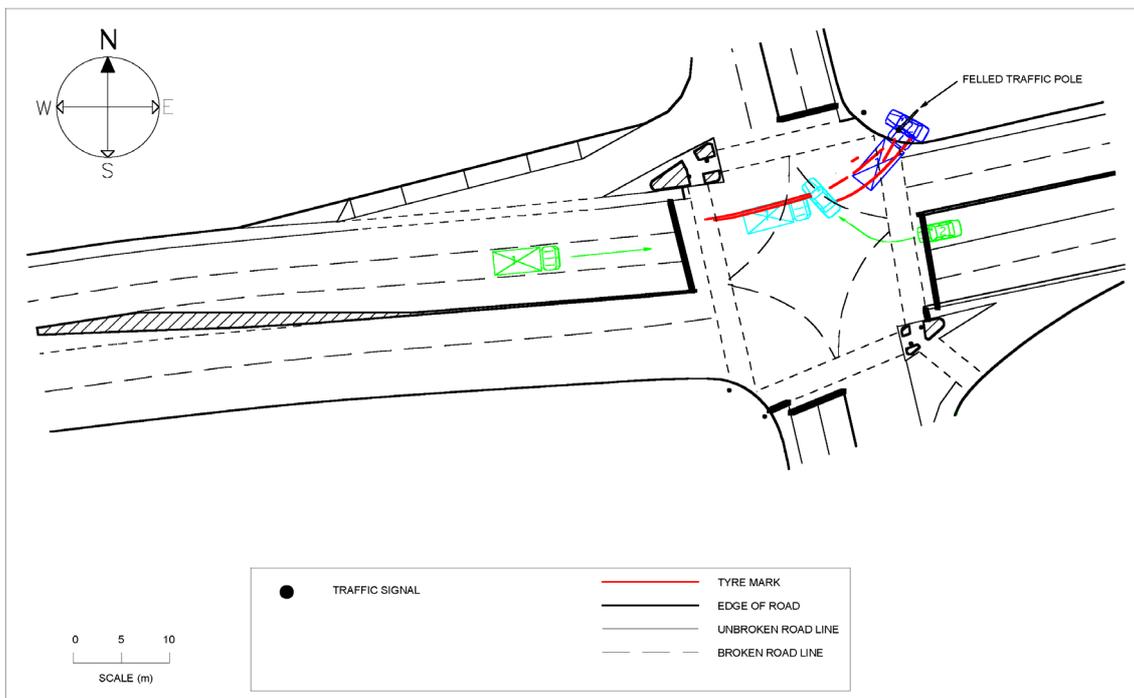
A site diagram is shown in Figure 6. There is a slight kink in the western approach that was being used by the truck however the site satisfied current design standards. A comparison of right turn crashes at the major signalised intersections upstream and downstream of the site was made. These intersections had much higher traffic volumes but proportionately less right turn crashes than the crash site (Table 4).

Figure 6 – Site diagram showing intersection geometry, initial vehicle paths and final resting places

It is likely that a fully controlled right turn phase would have prevented the crash from occurring. This is known to significantly reduce right turn crashes by up to 80% (Bui, Cameron and Foong, 1991), yet the filter right turn is still used extensively on the basis of network efficiency.
