TRIAL EVALUATION OF WIDE, AUDIO-TACTILE, CENTRELINER CONFIGURATIONS ON THE NEWELL HIGHWAY

Connell D.J., Smart W.J, Levett S., Cleaver M., Job R.F.S., de Roos M., Hendry T., Foster J., Saffron D...
New South Wales Centre for Road Safety, Roads and Traffic Authority of NSW
Email: Dylan_Connell@rta.nsw.gov.au

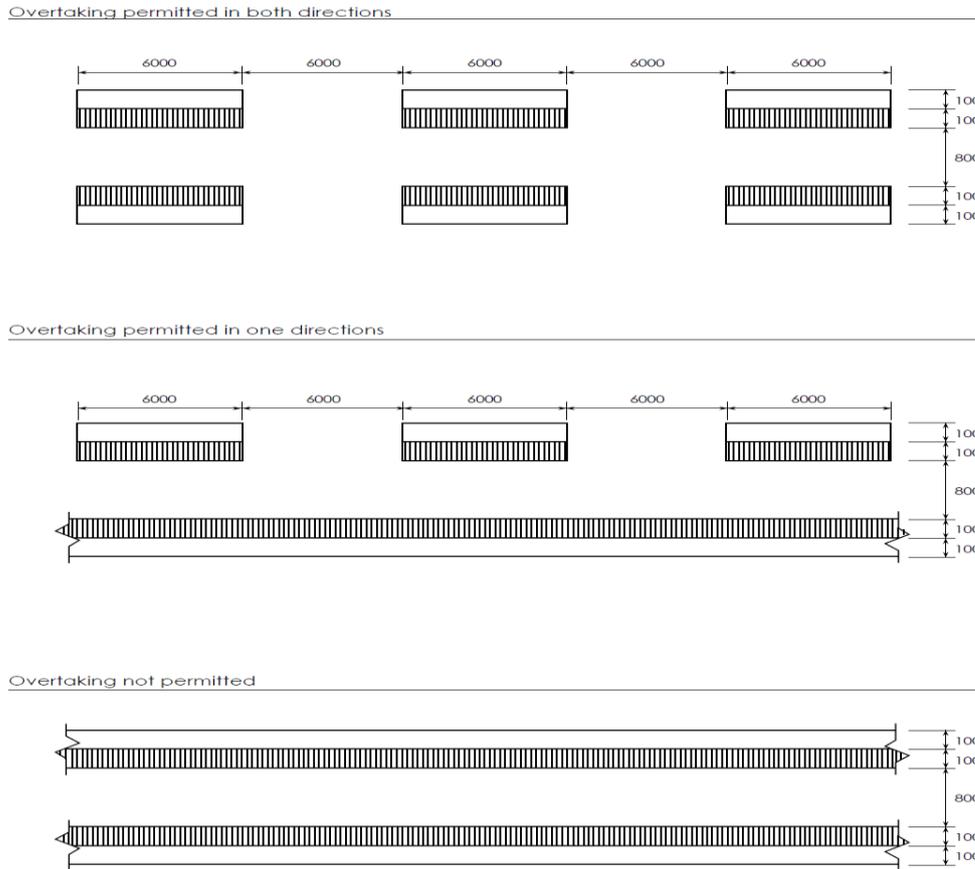
Figure 1.1 – Trial Line Marking Configurations

Specifically, this was a 100-mm wide, solid line abutted by a 100-mm wide audio-tactile line, an 800-mm gap to another 100-mm wide audio-tactile line abutted by a 100-mm wide solid line. In total this results in a 1.2m gap (800-mm + 200-mm + 200-mm) provided between the opposing directions of travel.

The line markings configurations are shown below in **Figure 1**.

The wide centreline markings, unlike those used elsewhere, allow overtaking where it is safe to do so. The marking has audio-tactile properties along both the centre line and edge line, aimed at alerting drivers if they are drifting outside their lane.

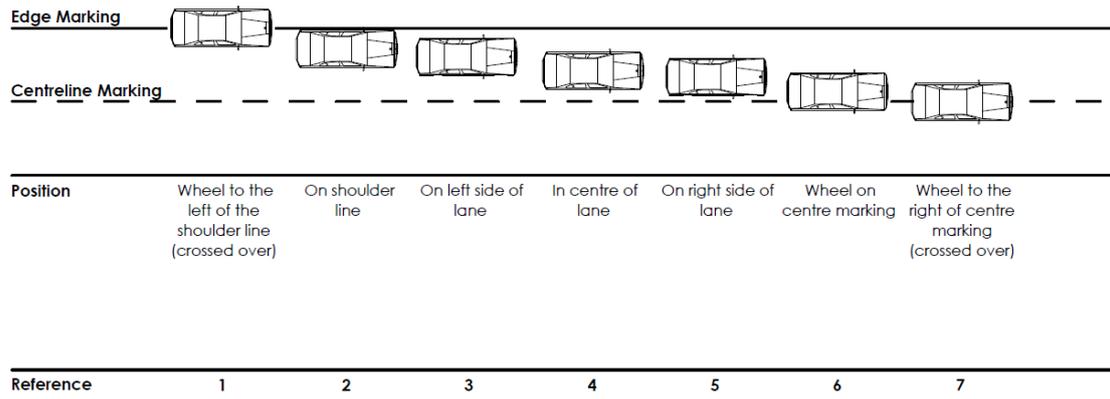
Figure 2 – Vehicle position

Driver behaviour was analysed in terms of the position of the car in the road at a number of locations in the trial sites. The car’s position was observed in relation to the road markings (whether it was in the middle of the lane, to the shoulder side of the lane, to the centreline side of the road or whether it ran along/over the shoulder / median road marking).

The recorders enabled the vehicle position to be seen quite clearly. From the video it became apparent that some cars changed their position over the extent of the video panorama. It was decided therefore to record the position of a vehicle that it held for the majority of the time whilst being observed, unless it went on or over the shoulder or centreline marking in which case it was recorded in accordance with **Figure 2** below as in cases 1, 2, 6 or 7. In such cases, the number relates to a vehicle crossing of the shoulder centreline marking.

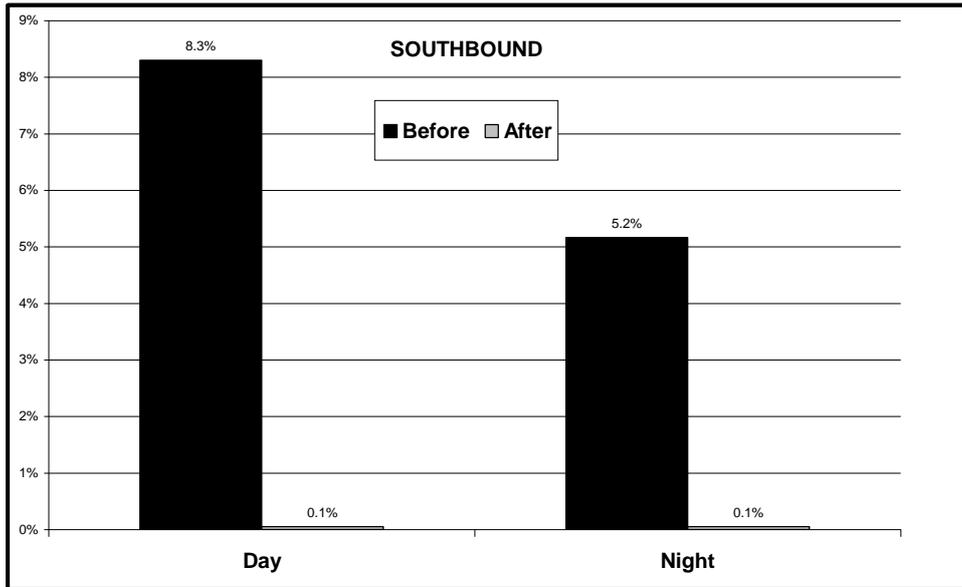
Figure 3 – Proportion of vehicles crossing onto or over the edge line at Parkes, in daylight and darkness, before and after installation

There were large reductions in the proportion of vehicles crossing onto or over the edge line or the centreline, as shown in **Figures 3 to 6**.

Chi square tests were undertaken separately by site and by natural lighting (daylight or darkness): four tests in all. For each test the calculated p was zero (using PASW Statistics 18). All the effects were substantial and in the same direction. The new linemarking greatly improved lane-keeping.

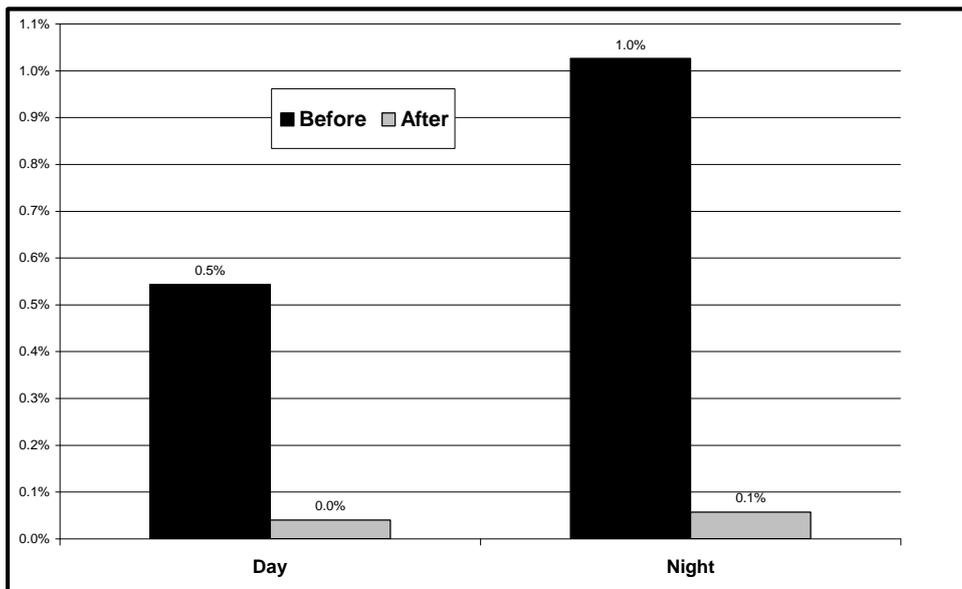
Figure 4 – Proportion of vehicles crossing onto or over the centreline at Parkes, in daylight and darkness, before and after installation

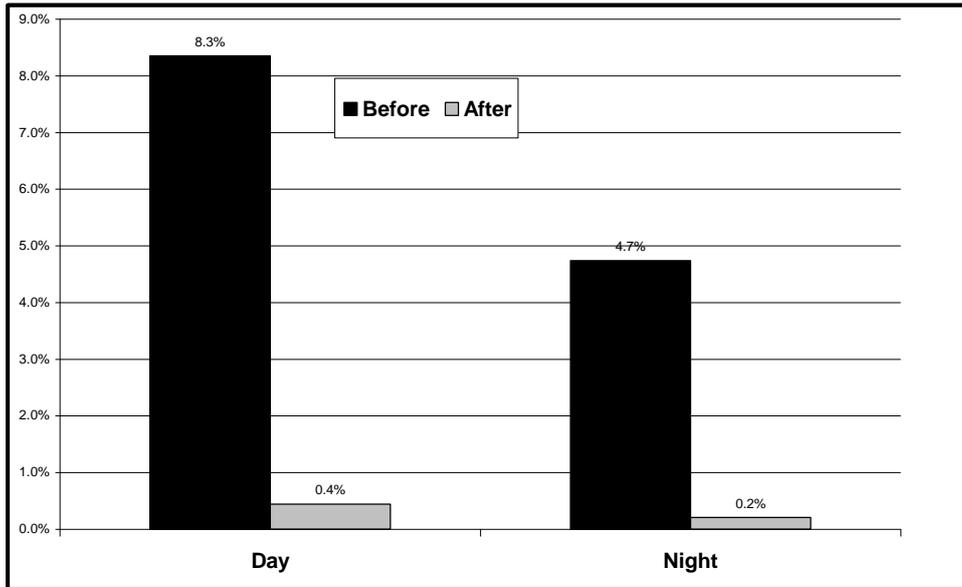
Figure 5 – Proportion of vehicles crossing onto or over the edge line at West Wyalong, in daylight and darkness, before and after installation

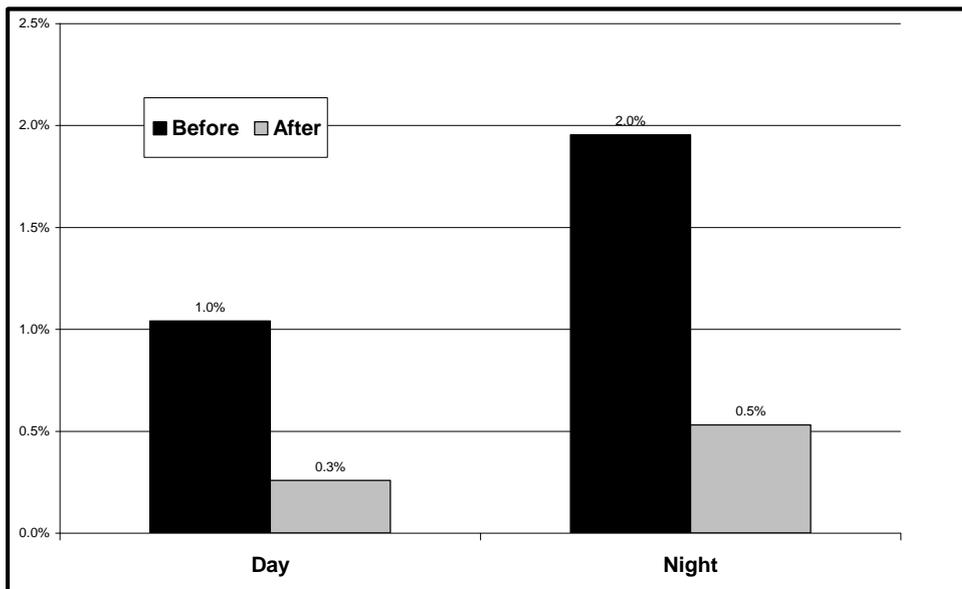
Figure 6 – Proportion of vehicles crossing onto or over the centreline at West Wyalong, in daylight and darkness, before and after installation
