# Mitigating localised sand accumulation using wire rope safety barrier

## Abstract

Sand accumulation on highways is an ongoing problem for road authorities in arid areas across the globe. Typical methods to prevent sand accumulation on highways include landscaping, sand fences and desert resistant vegetation; but these incur high construction and maintenance costs. This paper discusses the impact of different road safety barrier types used in areas prone to sand accumulation and provides a case study of the impact of replacing an existing steel W-beam median barrier with a trial section of wire rope barrier. The trial proved to be successful in mitigating localised sand accumulation and is recommended for consideration in desert environments.

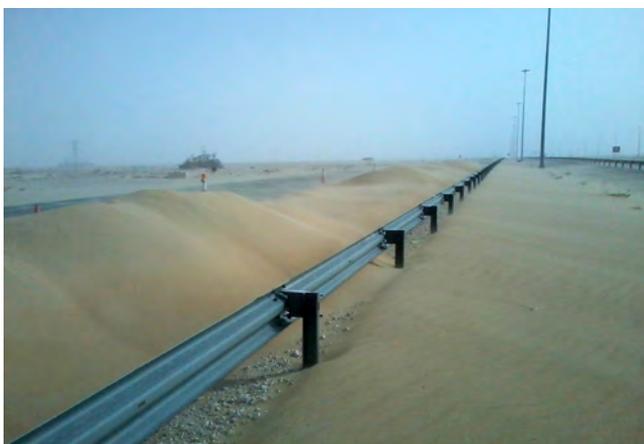
Figure 1. Heavy sand build up after a period of strong wind

Despite the use of sand fences on the north side of the carriageway, sand is able to flow past these fences and onto the road. The sand barriers are approximately 70 to 80m long and positioned diagonally with the road, with the nearest edges being set back approximately 50m from the edge of the road and the furthest edge being 100m away. The barriers are 1.5 to 2.5m high and have a porosity of approximately 0 to 20 percent. Sand regularly builds up immediately beyond the fences during peak sand drift seasons. The two rows of steel W-beam safety barrier on the median further disrupt the flow of sand particles that flow onto the road, which leads to a buildup of sand on the median and within the carriageway. Figure 1 shows an example of heavy sand accumulation after a period of strong wind.

This presents a significant on-going maintenance liability for the road authority to remove sand accumulated within the third and fourth lanes (fast lanes) of the eastbound

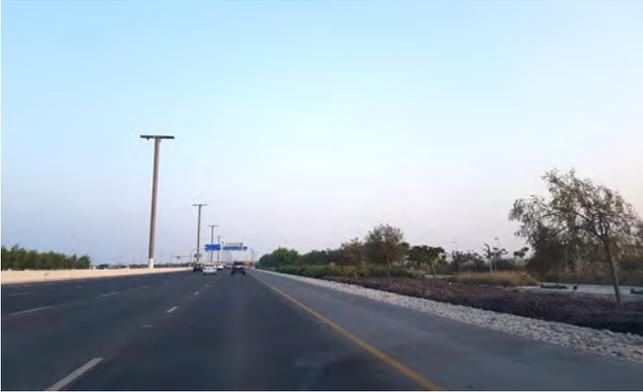
Figure 3. Example of extensive roadside landscaping and vegetation

Figure 3 shows a section of expressway in an urban fringe environment between Doha City and the Hamad International Airport (refer to Figure 6 regarding location). The roadside landscaping implemented in this case is similar to that recommended in Figure 2.

The highway infrastructure and landscaping shown in this photo was implemented as part of a multi-billion dollar roading project to connect Doha with the new airport. Because this site is located on the fringes of urban development, and possibly due to the extensive use of roadside vegetation, it is not typically subject to wind blown sand problems.

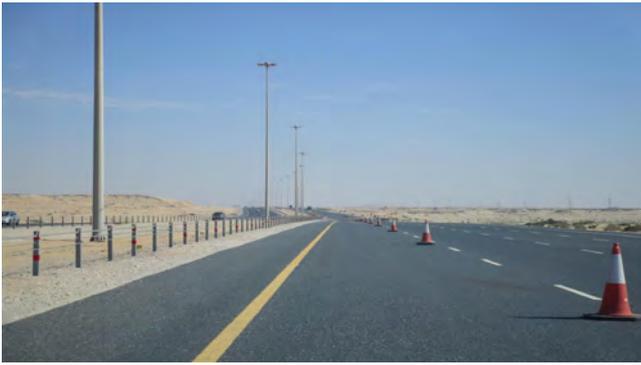
Figure 8. Wire rope barrier installation (August 2015)

A trial was undertaken on a remote section of Salwa Road, approximately 80 kilometres west of Doha, Qatar, to replace sections of existing steel W-beam median barriers (Type N2 under the European EN1317 specification) with a wire rope safety barrier system. The wire rope safety barrier comprised a four-strand high tension system to Test Level 4 under the US NCHRP-350 specification (Make: Armorwire DSR galvanized, grade 1320 RHL). Figure 6 shows the general location of the trial site, noting the remoteness from any developed areas. Figure 7 provides the general climatic conditions of the studied area and Figure 8 shows the installed wire rope barriers on the median.

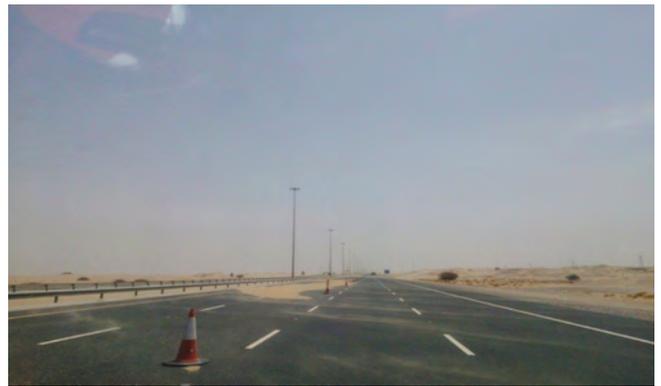
Figure 10. Sand accumulation with existing two-row steel W-beam barriers

Prior to the trial, with the existing two-row W-beam median barriers (Configuration 1), sand would accumulate in significant deposits on the hard median strip and within the third and fourth (fast) lanes. Figure 10 provides a typical

example of sand accumulation with the two-row W-beam barriers. During, and following, strong wind periods the third and fourth (fast) lanes of the eastbound carriageway would be closed to live traffic using traffic management measures.

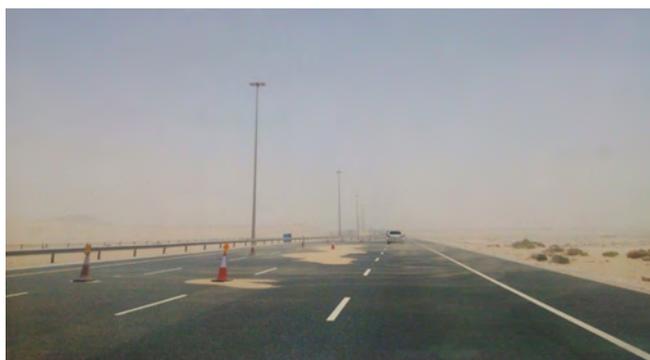
Figure 11. Sand accumulation with a split wire rope and steel W-beam barrier configuration

When the first wire rope barrier was installed on the westbound carriageway (Configuration 2: split wire rope / W-beam barriers), there was a noticeable effect of sand being deposited further across the eastbound carriageway in the second lane. Figure 11 shows the shift in sand accumulation patterns under Configuration 2 with the split wire rope / W-beam barriers.

This situation required even further lane closures with sand accumulating across into the second lane. This result also highlights the need to carefully consider the potential impact of road safety barrier location and the sequencing of barrier types on potentially adverse sand accumulation patterns.

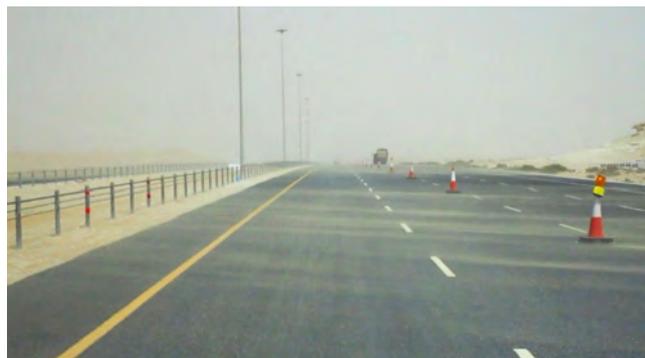
Figure 12. No sand accumulation with two-row wire rope barriers

Once the second row of wire rope safety barrier was installed on the eastbound carriageway (Configuration 3: two-row wire rope), it was clear to see that sand flows were

less obstructed by the barriers. Figure 12 shows a typical observation where sand is relatively free to flow across the road without resulting in significant deposits.

There were no significant sand deposits observed under the two-row wire rope safety barrier configuration as a result of wind speeds of 20 km/h or greater. Moreover, the wire rope safety barrier’s vertical surface area is estimated to have a high porosity value of over 90%, compared to approximately 60% for a W-beam barrier (estimated from NZTA, 2017), which allows the windblown sand to pass through and
