## **Wire Rope Barrier Monitoring System (Load cell communication) – An overview**

### **Abstract**

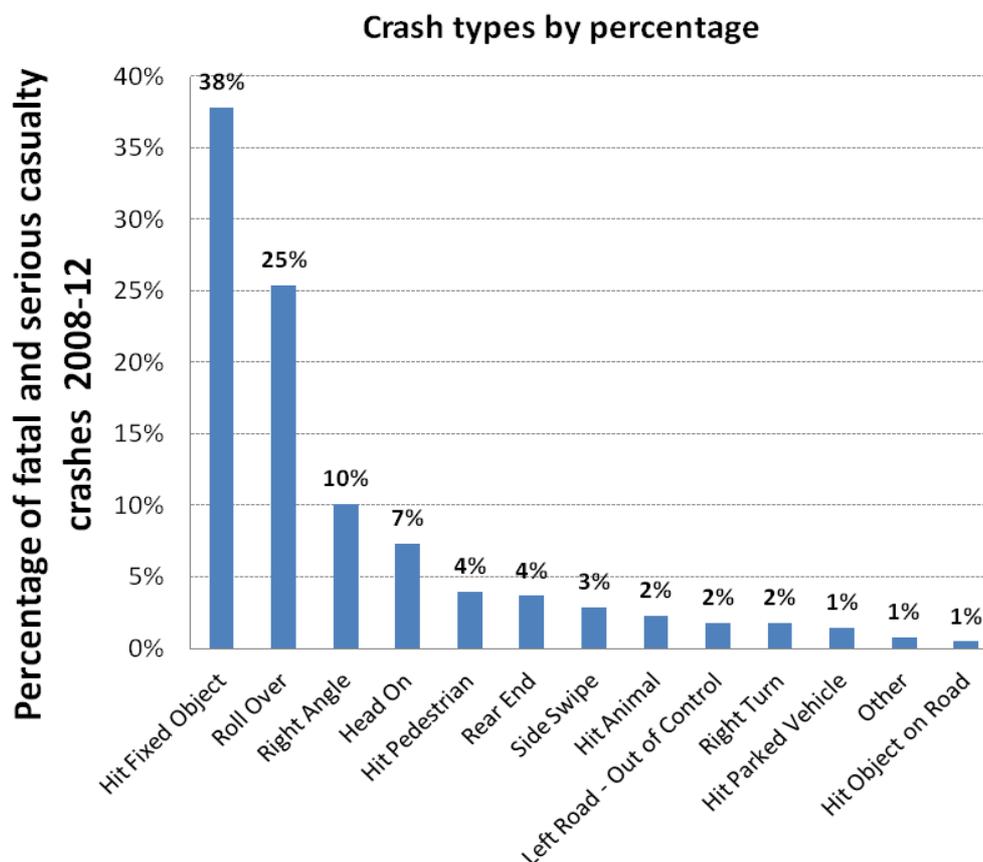
**Figure 1**

Percentages of fatal and serious casualty crash types on rural roads in South Australia 2008-2012, DPTI (2013)

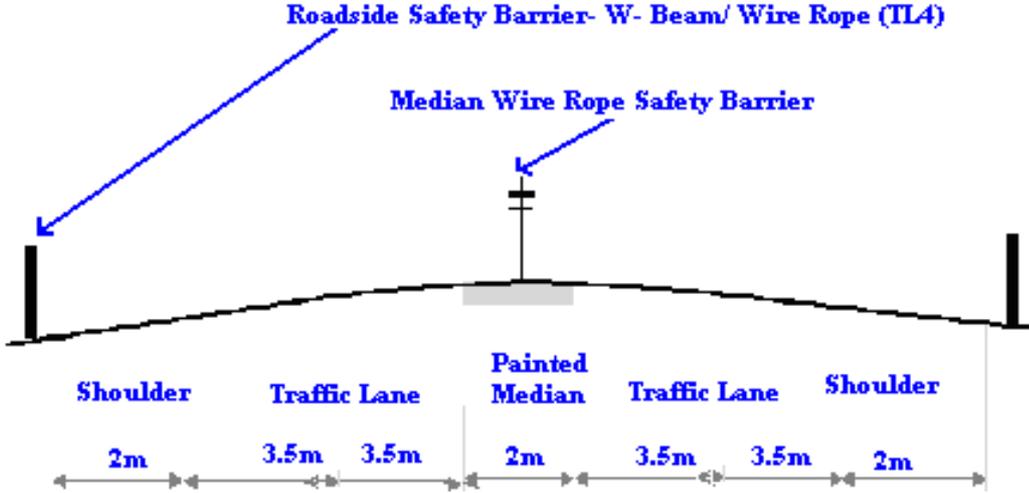
**Figure 2**  
Cross Section dimensions of Median Wire Rope Safety Barrier on Victor Harbor Road at Willunga Hill, South Australia

Two meter wide shoulders were considered appropriate for this project sufficient to allow traffic to pass a stopped vehicle with caution by shifting position in the lane without encroaching into the adjoining lane.

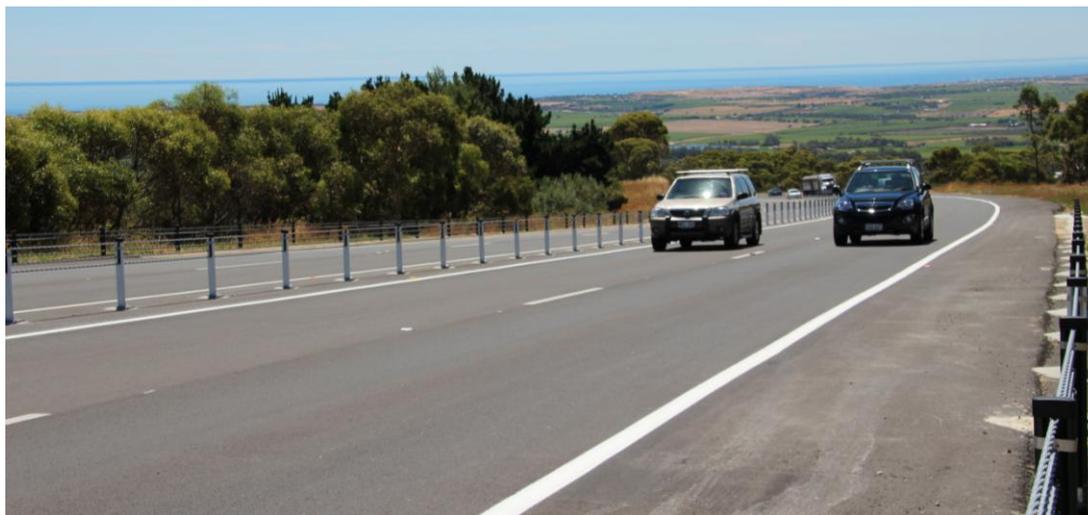
**Figure 3**  
View of median wire rope barrier at Willunga Hill, looking north

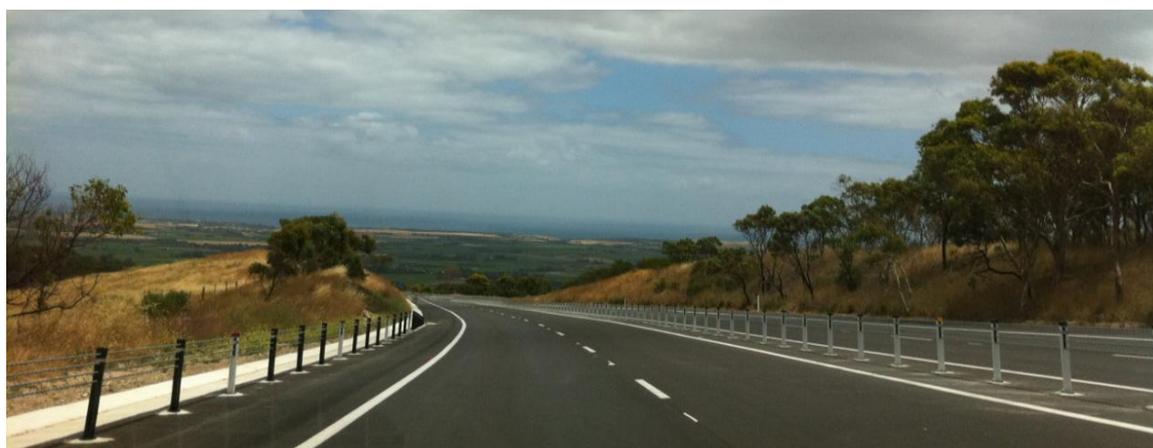
**Figure 4**  
Median and roadside wire rope barrier at Willunga Hill, looking north

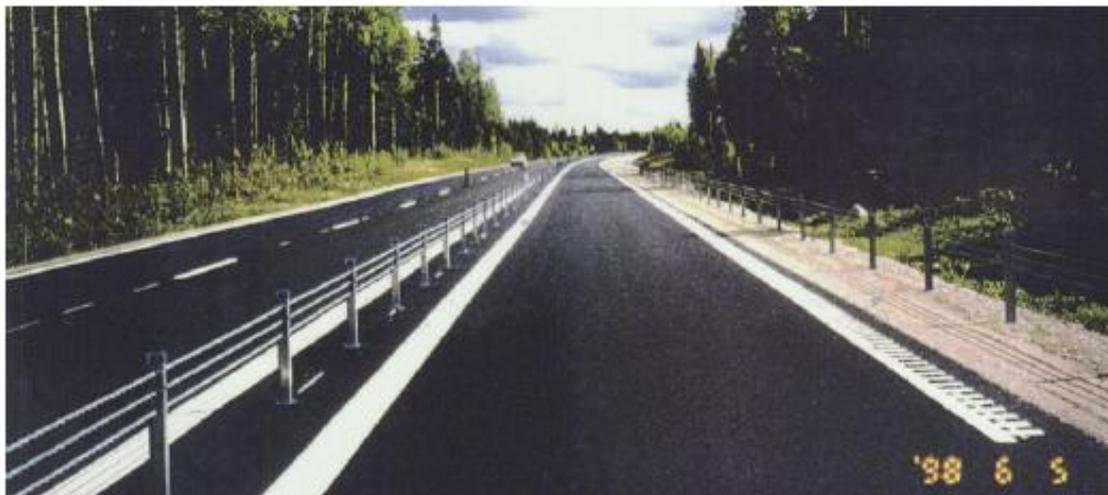
**Figure 5**

Example of median and roadside barriers in Sweden (Bergh et al, 2005)

It therefore seems that part of the improved safety performance of the 2+1 roads may come from the treatment of the roadsides, including wire rope barriers as shown in **Figure 5**.

Increased maintenance costs were experienced in the Swedish design due to the limited median width of 1.25-1.50 m for the cross-section of 13-14m. (Bergh et al, 2005)

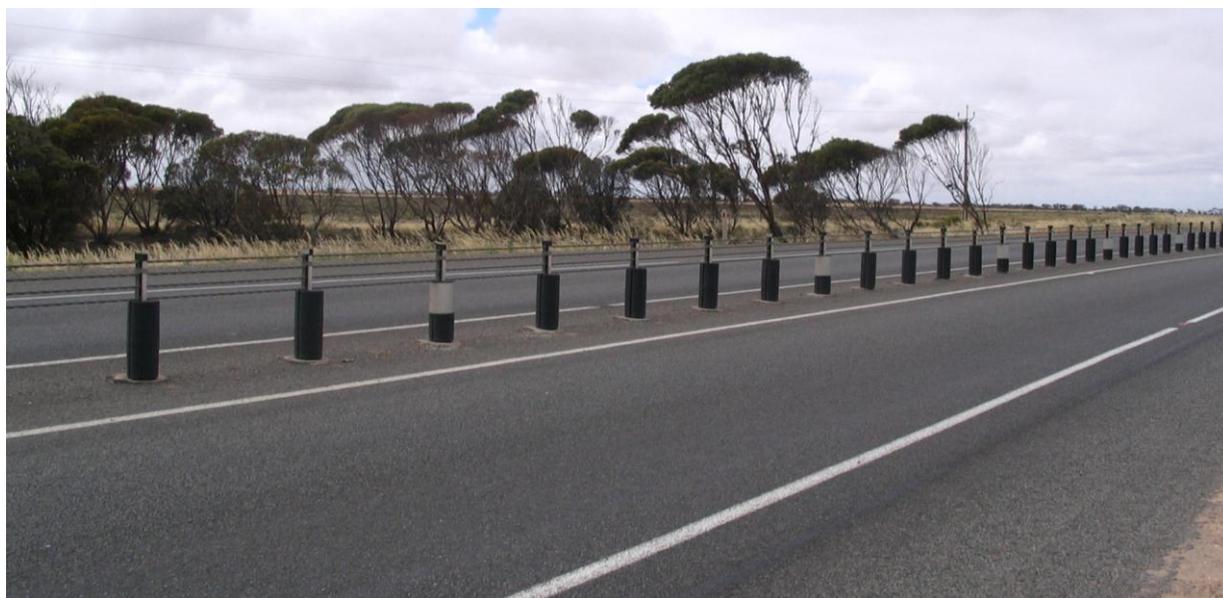
**Figure 6**

Median Wire Rope Barrier on Port Wakefield Road, South Australia

In the four years since installation in June 2009, 22 hits have been reported with the median wire rope barrier, resulting in just 2 minor injuries and the rest property damage only, potentially saving lives and serious injuries.

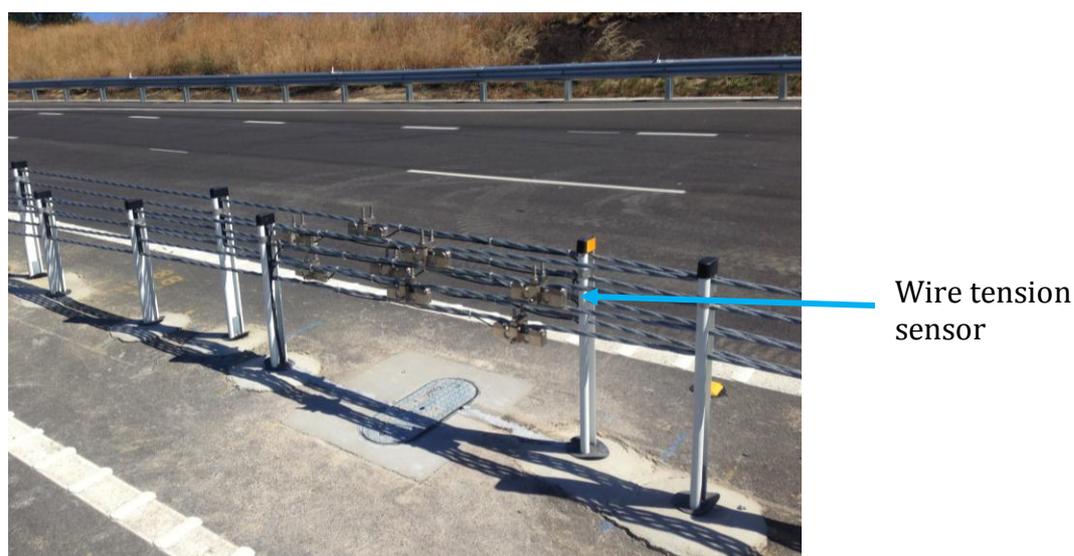
Load cell monitoring system at Victor Harbor Road, Willunga Hill, South Australia.

The barrier was installed in two sections that overlap in the middle, adjacent to the monitoring equipment as shown in **Figure 7**. The sections are approximately 1.0 km each in length. The barrier is continuous across the entry point to the scenic lookout on the northern side of the road and prevents right turn in and out of this access road for safety reasons. There are curves in both sections.

Under this option wire tension sensors are attached to the wire ropes as shown in **Figure 7** and connected by a slot cut underneath the road, directly to the main enclosure communications mounted on the roadside as shown in **Figure 10** performs all acquisition, analysis and remote data communications. Slot-cuts are made in the road from the shoulder to the median strip to provide a cable path. **Figure 9** shows the system overview.

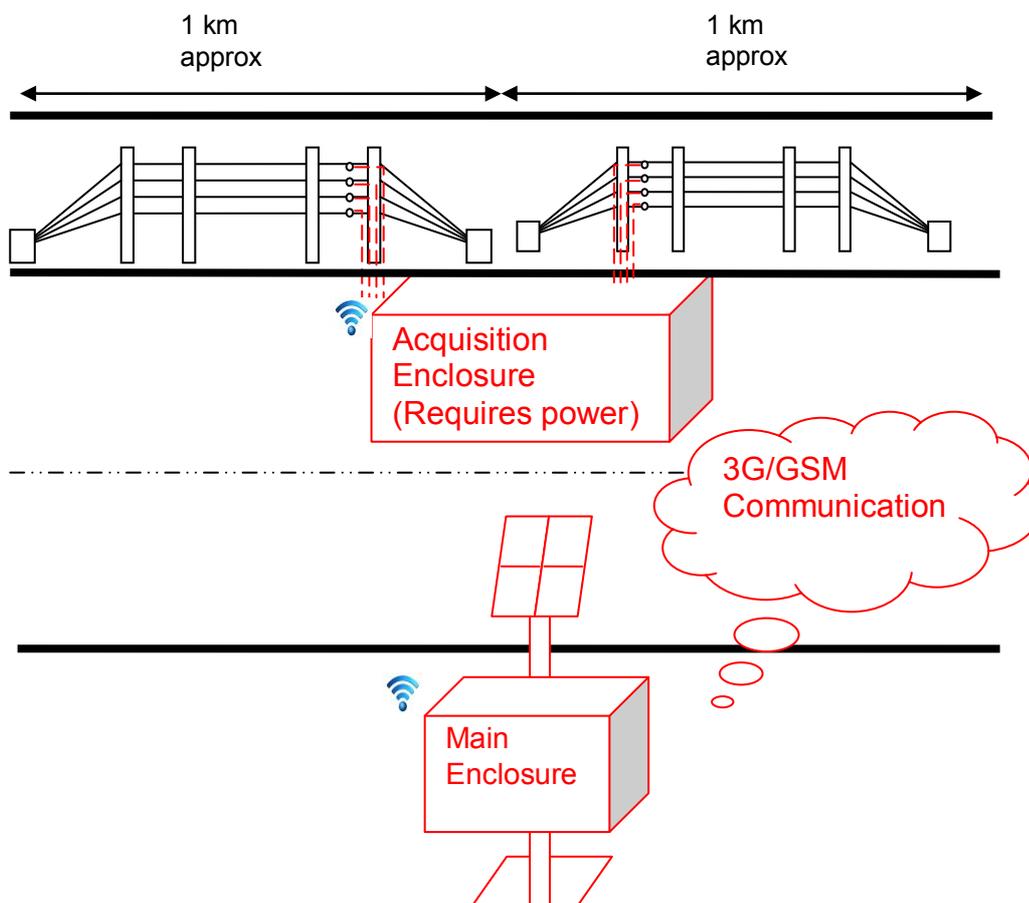
**Figure 8**

Wireless Option for wire rope monitoring system schematic diagram

The issue with this option was the limited power supply from batteries which could last only up to 3 months and require regular visits to replace the batteries in the underground enclosure, as shown in **Figure 8**.

However, the wireless option was dropped primarily because the acquisition enclosure in the middle of road requires power to run. The acquisition enclosure contains wireless sensor node(s) to acquire data and readings from the strain sensors and transfer data wirelessly to the main enclosure (at the roadside). The main enclosure contains a real-time controller and would wirelessly communicate with the acquisition node(s), in addition to perform data storage and 3G/GSM communication/data transfer.

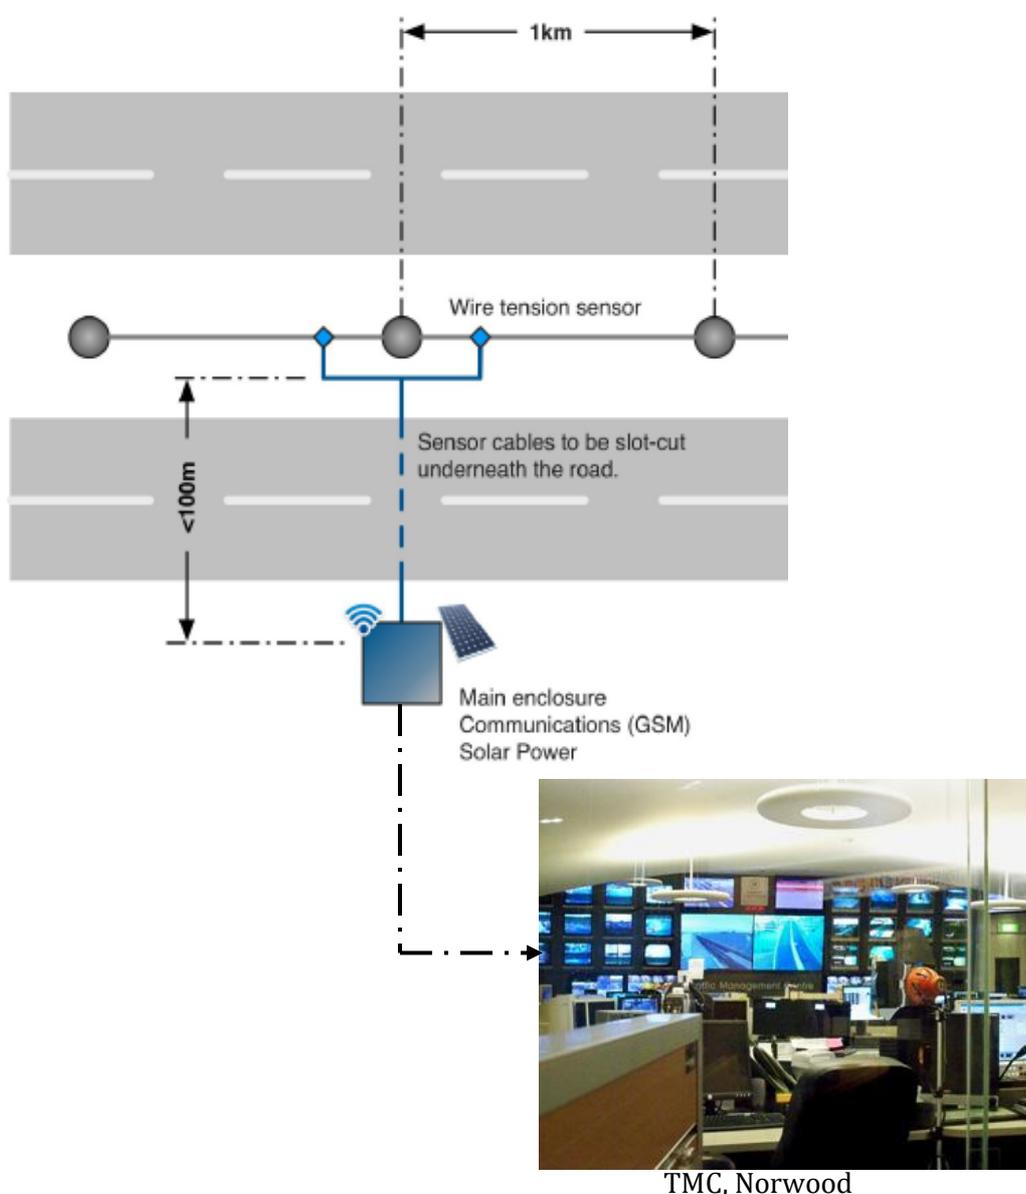
**Figure 9**  
Wire rope monitoring system schematic diagram

The system is set up to monitor two separate barrier sections with a maximum of 8 sensors (4 sensors per section, 1 sensor per rope). Power for the main enclosure is supplied by a solar panel mounted above the enclosure that charges the main battery, as shown in **Figure 10**. The main enclosure is pole mounted with sufficient security measures.

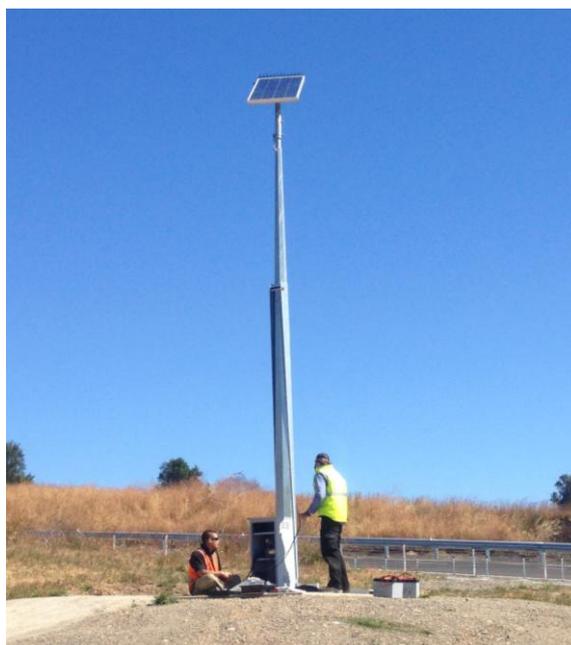
**Figure 10**

Remote monitoring system electronic relay box, main enclosure and solar panel

The main enclosure is 3G/GSM communications capable for remote data transfer and for SMS notifications to the TMC at Norwood.

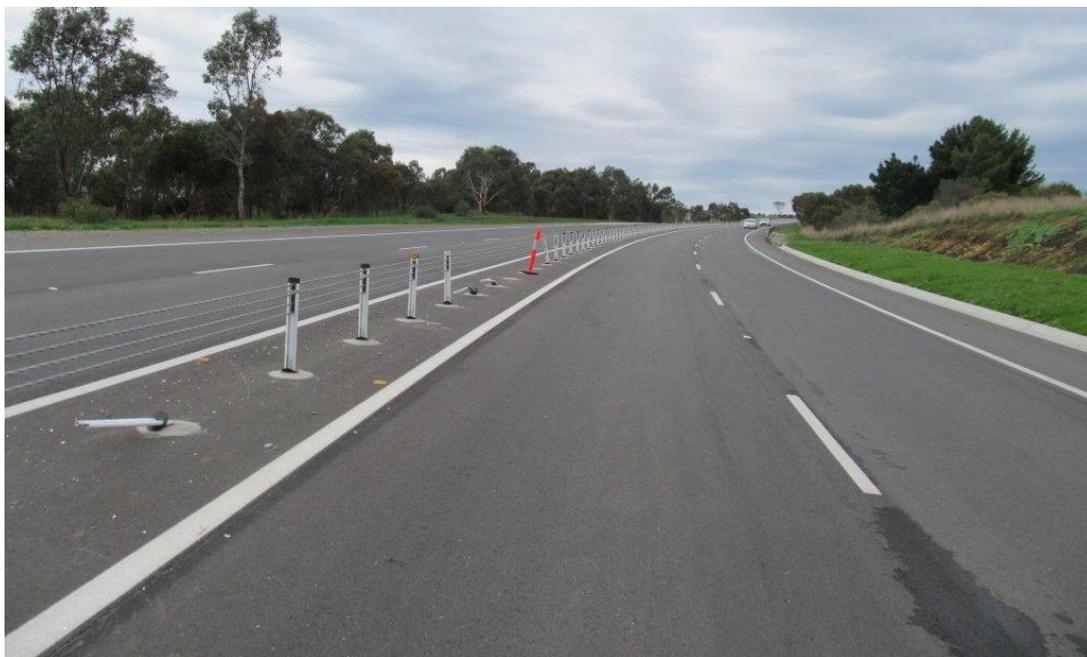
**Figure 11**

Damaged wire rope posts at Willunga Hill after being hit

To date the median wire rope at Willunga Hill has experienced two hits resulting in property damage only, with barrier damage from one strike as shown in **Figure 11**.
