Evaluation of an Alternative Pedestrian Treatment at a Roundabout

Nimmi Candappa¹, Nicola Fotheringham¹, Michael Lenné¹, Bruce Corben¹, Charlotta Johansson², & Paul Smith³.

1. Monash University Accident Research Centre (MUARC), Victoria.

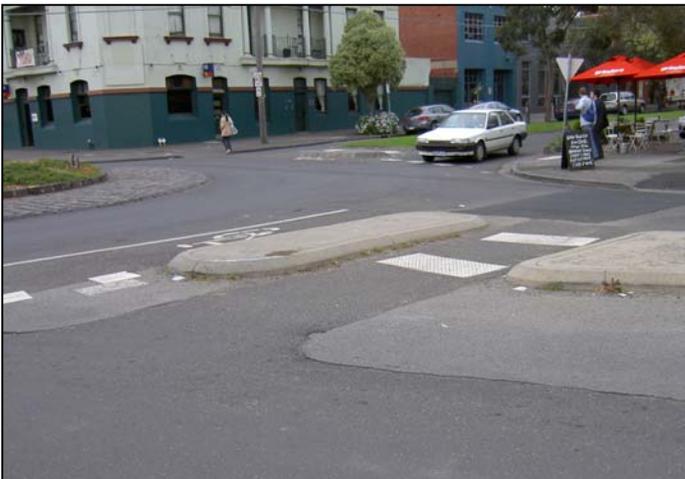
Prior to treatment, the roundabout consisted of a large circular central island, pedestrian refuges, pram crossings and standard roundabout signs at roundabout entry points. Linemarking within the intersection consisted of two white stripes within each pedestrian refuge and standard broken lines at the vehicle entry of each leg to the roundabout, as well as bicycle lanes through the roundabout, (Figure 1). In this case the pedestrian refuges are not specifically set back the standard 6 m.

Figure 1 – pre-treatment

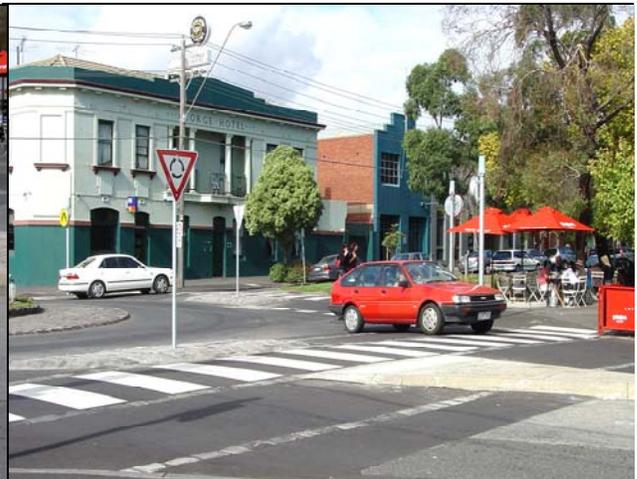
Post-treatment, (Figures 2 and 3) the roundabout consists of zebra crossings (flush with the footpath), placed over gradual speed humps immediately prior to the roundabout entrance. The pedestrian crossings comprise zebra pavement markings - broad white stripes, perpendicular to vehicle travel - and roadside signing. Although approach islands still exist at each leg, the islands do not visually break the continuance of the crossing. Further, crossing signs that are externally-illuminated at night face drivers on each leg, and more pronounced linemarking has been introduced. The bicycle lanes through the roundabout have been removed. No modifications have been made to the central island.

Figure 2 – post-treatment

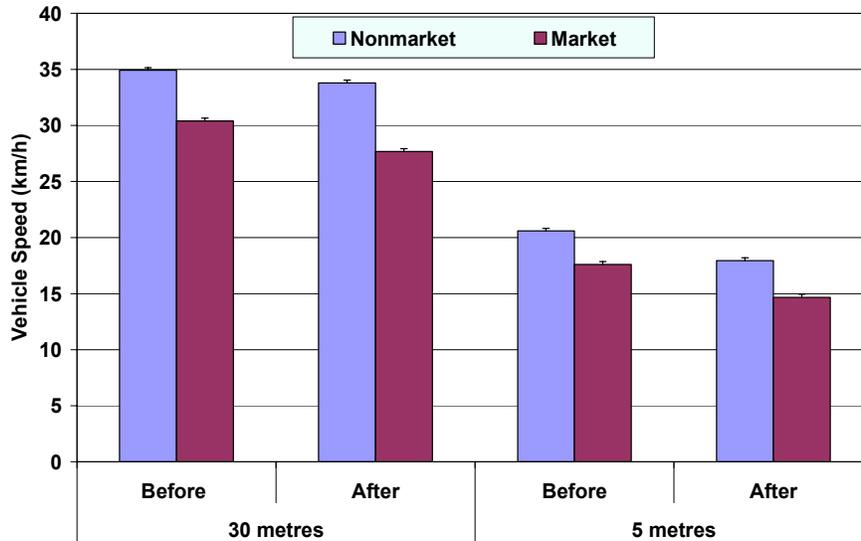
Vehicle speeds were measured 30 m and 5 m from the crossing on market and non-market days. A total of 2036 and 1936 speed measurements were recorded 30 m from the crossing (before and after, respectively) and 1370 (before) and 1258 (after) measurements 5 m from the crossing. Mean speeds 5 m from the roundabout were lower in the after period with speeds of 19.10 km/h (before) and 16.31 km/h (after) (see Figure 4). The proportion of vehicle speeds exceeding 20 km/hr and 30 km/h also decreased in the after period. Analyses confirmed that there was a significant main effect for *treatment period* ($F(1,2620) = 116.04, p < 0.001$). Mean speeds were also significantly lower on market days (16.13 km/h) compared to non-market days (19.27 km/h) ($F(1,2620) = 146.26, p < 0.001$). The interaction between the two factors was not significant.

Mean speed 30 m from the crossing was also significantly lower in the after period with mean speeds of 32.7 km/h (before) and 30.7 km/h (after) ($F(1,3964) = 60.99, p < 0.001$). Mean speeds were lower on market days compared to non-market days at 30 m (29.1 km/h and 34.4 km/h, respectively). Analysis confirmed there was a significant main effect for *day* ($F(1,3964) = 462.98, p < 0.001$) and a significant interaction between *treatment period* and *day* ($F(1,3964) = 10.40, p < 0.001$). Figure 4 shows a greater difference between market and non-market days in the after period compared to the before period, 30 m from the crossing.

Figure 4: Mean speeds on market and non-market days before and after treatment

Lower vehicle speeds at both 30 m and 5 m suggest greater safety for the pedestrian allowing more predictable gap selection; creating longer time to collision - allowing greater chance for effective braking; and critically, producing less severe injury consequences in the event of a crash.

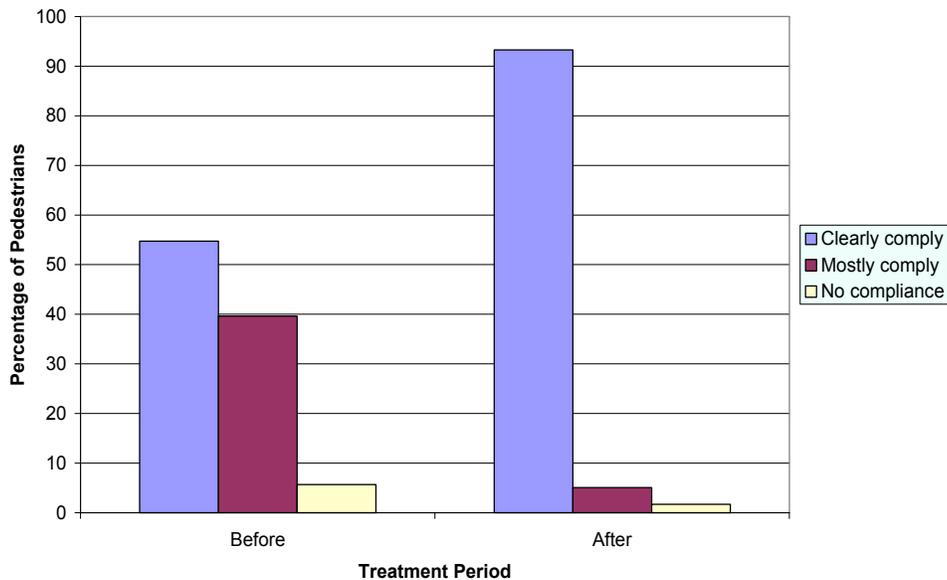
As shown in Figure 5, the difference between pedestrian compliance with the crossing in the before and after periods was significantly different, ($\chi^2(2)=719.6, p<0.001$). Levels of clear non-compliance with the crossing also dropped from 6% in the before-period to only 2% in the after-period.

Figure 5: Percentage of pedestrians complying with crossing before and after treatment

As a result of increased compliance at the crossings, potential for pedestrian/vehicle conflict is more restricted to a specific location. The location is also directly within the intersection, giving prominence and priority to the pedestrian and potentially heightening driver awareness for pedestrians at this location, thereby increasing level of safety for the pedestrian. It should be
